## A New Approach for Early Detection of PCB Pad Cratering Failures

Anurag Bansal, Gnyaneshwar Ramakrishna and Kuo-Chuan Liu  
Cisco Systems, Inc.,  
San Jose, CA  
anurbans@cisco.com

### Abstract

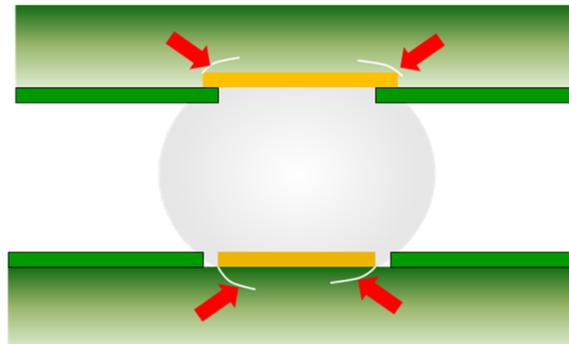
The term “pad cratering” refers to the formation of fine cracks underneath BGA pads either in the PCB laminate material or in organic package substrates. Figure 1 schematically depicts the possible location of these cracks. Due to external mechanical load, the cracks initiate due to stress concentrations arising from the corner of the copper pad and the material property mismatch between copper and the laminate resin. The cracks propagate within the resin, up to the point where the underlying glass fiber bundles are encountered. Under subsequent loads, the cracks continue to grow along the interface between the resin and glass fibers, and also beyond the glass fiber bundle. Prior studies have shown that the extent of crack growth under the BGA pads is highly dependent on the location and orientation of glass fiber bundles with respect to the BGA pad [1].

Figure 1 - Schematic Depiction of Pad Cratering

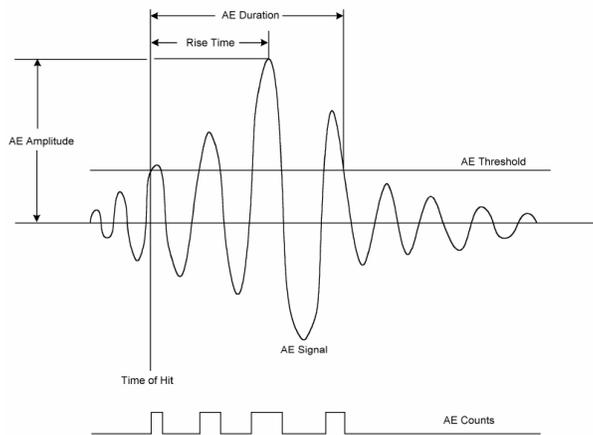
**Figure 2 - Typical Acoustic Emission Waveform and Related Parameters [14]**

Acoustic Emission (AE) refers to the spontaneous release of transient elastic waves due to a sudden redistribution of stress in a material. When a structure is subjected to internal damage which can be caused by an external stimulus such as a change in pressure, load, or temperature, the localized damage will trigger the release of energy, in the form of acoustic/stress waves, which propagates in a radial direction from the source and is recorded by sensors. This technique has been used for decades to monitor the initiation and growth of cracks, slip and dislocation movements, metal twinning, and phase transformations. Acoustic emission monitoring is routinely used to monitor the integrity of pressure vessels and concrete structures. In composite materials, matrix cracking, fiber breakage and delamination contribute to acoustic emissions [13]. A schematic representation of a typical AE waveform is shown in Figure 2, superimposed with the key parameters that are used to define an AE “hit”. Additional details on the applications, parameter definitions, and waveform processing techniques may be found in the literature [13].

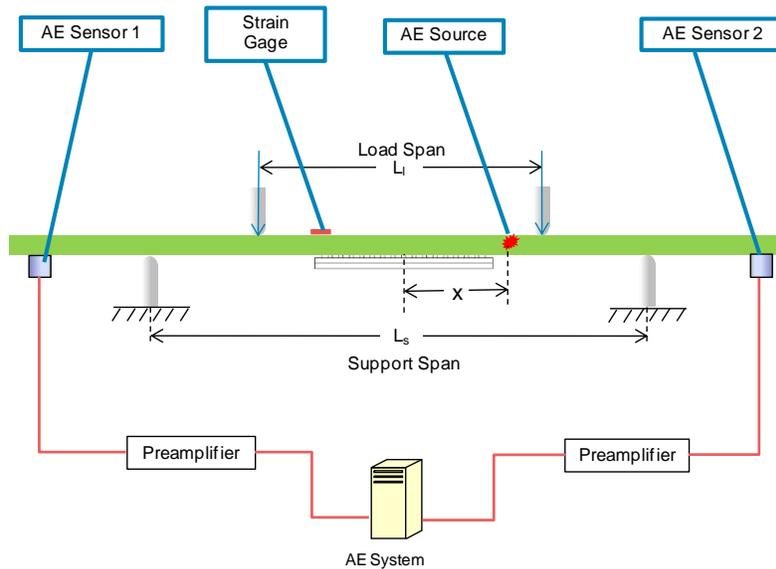
During the bend tests, two acoustic emission sensors were clamped on the ends of the PCB, as shown in Figure 3. The sensors were connected to the AE monitoring system via a preamplifier. The acoustic data acquisition rate for both sensors was 10 MHz. Figure 4 shows a picture of the HSBGA board during test.

**Figure 3 - Schematic of Bend Test Set-up with AE Sensors**

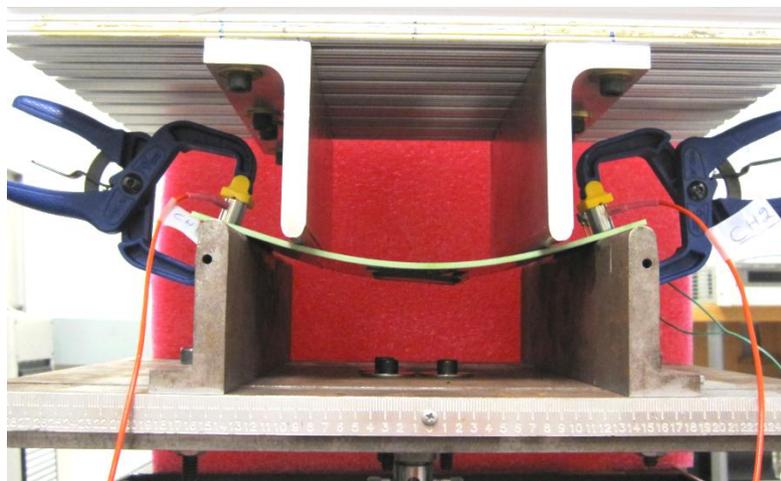
**Figure 4 - Four Point Bend Testing of HSBGA board**

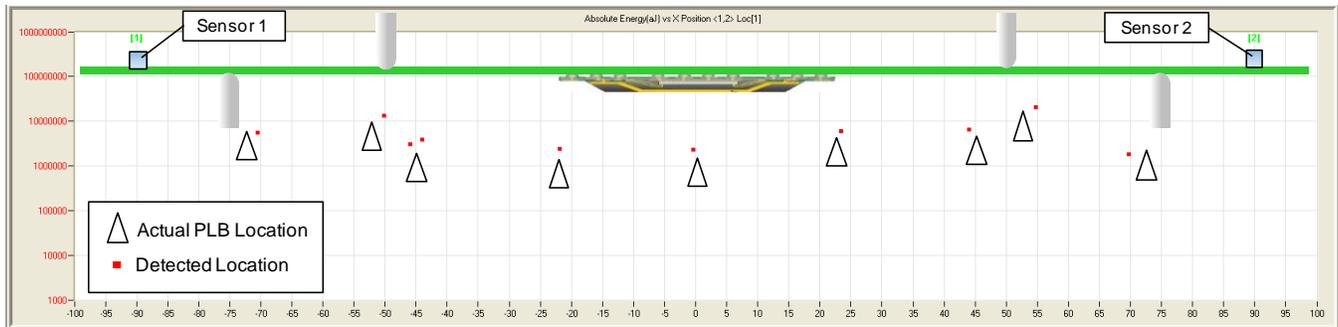
Once the velocity of sound within the PCBs was determined, PLB tests were performed in order to determine the accuracy of linear source location. The pencil leads were broken at pre-determined locations on the board and the AE system was used to detect the x-location. Figures 5 and 6 show the PLB test results for the HSBGA and CABGA boards respectively. The absolute energy of the signal is shown along the y-axis, and the x-location is shown on the x-axis. In order to account for the possibility of acoustic wave attenuation and secondary wave reflection from the fixture anvils, the tests were conducted with the board placed within the fixture and applying a preload to ensure good contact between the anvils and the board. A schematic of the BGA package, the loading and supporting anvils, and the sensor locations have been superimposed for convenience.

**Figure 5 - Linear Source Location Using PLB Test for HSBGA Boards**

Upon comparison of the actual PLB locations and the locations detected by the AE system, it is estimated that the detected x-locations are accurate in the range of  $\pm 1$  mm at or near the package edge,  $\pm 2$  mm near the loading anvils, and  $\pm 3$  mm near the supporting anvils. This result is consistent with the expectation from equation (2) that the accuracy of the linear location (x) will be better if the source is located near the center of the board, resulting in a small  $\Delta t$  value.

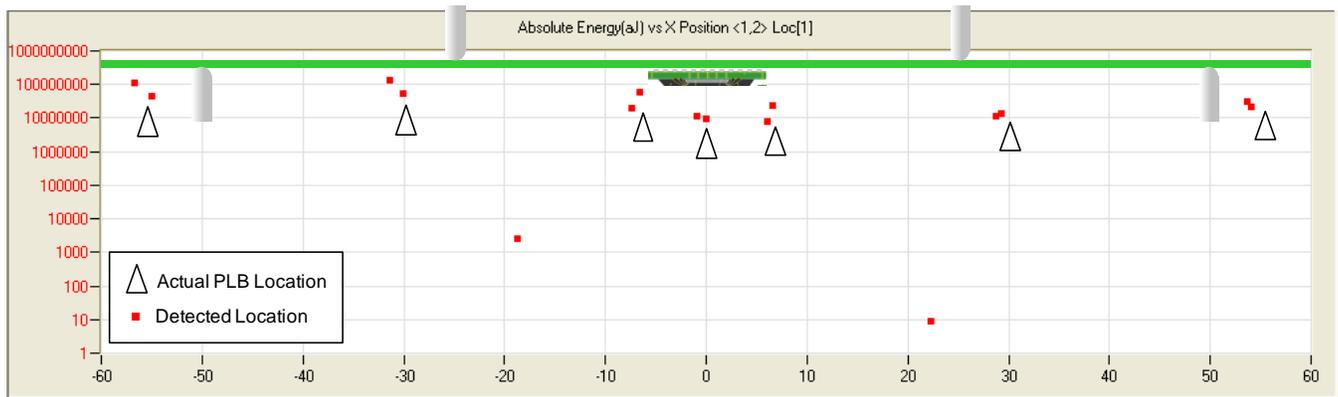
**Figure 6 - Linear Source Location Using PLB Test for CABGA Boards**

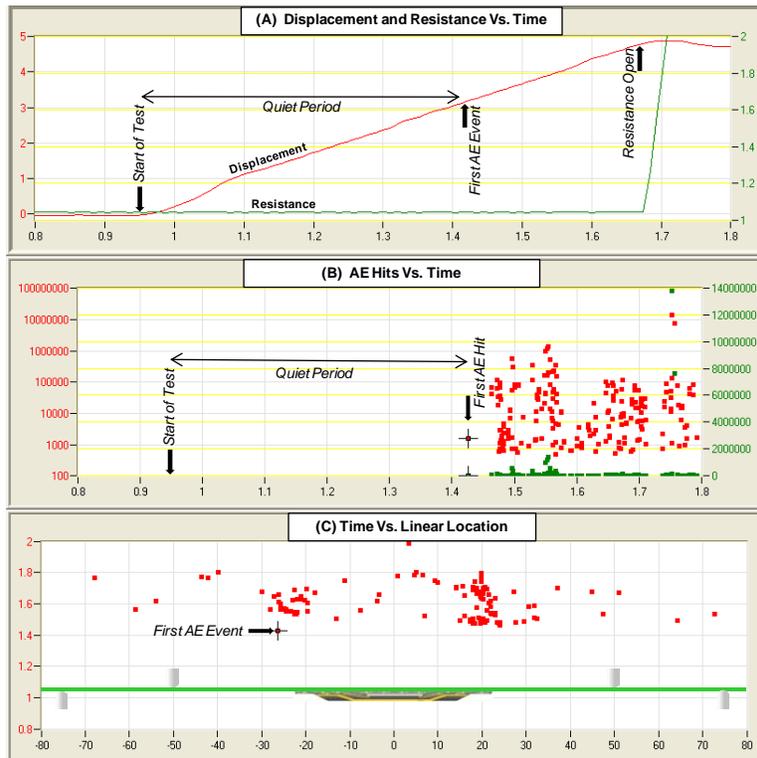
Figures 7 and 8 show the data acquisition results during the bend testing of a typical HSBGA and CABGA board. Figure 7 (a) shows the cross-head displacement and electrical voltage output versus time. Figure 7 (b) shows the Absolute Energy of AE hits detected by sensors 1 and 2 during the test. Figure 7 (c) shows time on the y-axis and the detected linear location on the x-axis. The AE events were based on detection of a hit by both sensor 1 and 2, and the linear location was calculated by the difference in the time when the two sensors detected a hit (equation 2). A schematic of the test board dimensions along with the loading and supporting anvils has been included for reference. It can be seen that after the start of the bend test, there is a duration of “quiet period” during which no AE hits were detected. This demonstrates that, with the AE system settings used in the test, no spurious signals were being recorded due to the frictional contact between the anvils and the test board. At a well defined instant in time, the “quiet period” ends due to a significant extent of AE activity, as indicated by the onset of the first AE hit and first AE event. The linear location plot shows that the initial AE events were primary located near the left and right edge of the package. This demonstrates additional validation that the initial AE events being detected were indeed emanating from damage being induced near the solder joints, and not due to activity near the fixture anvils. With the progression of time, a significant number of high energy AE hits were detected, and the linear location of the AE events shifted from the package edges towards the center of the package and the entire length of the board. The electrical resistance of the daisy chain circuit rapidly increased during this stage, indicating a catastrophic failure in the circuit. This trend, which was consistently seen in all of the boards tested, clearly demonstrates that the onset of electrical failure of the daisy chain circuit occurs very late after a significant extent of damage has been accumulated at the solder joints. In contrast, the acoustic emission methodology is able to adequately detect the onset of damage at the solder joints. This is validated by the finding that no spurious hits were detected during early stages of the test and the source of the first few hits was located near the package edges.

Figure 7 - Bend Test Result of a Typical HSBGA board

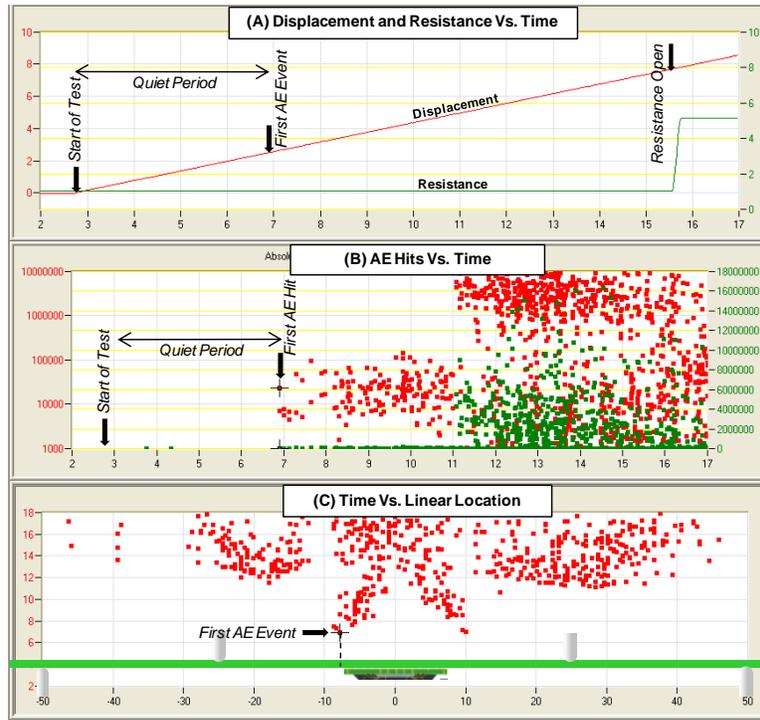
Similar to the HSBGA results, Figure 8 shows the same results and trends during bend testing of a typical CABGA board. Once again, there was a well defined “quiet period” during which no high energy hits or events were detected. Once the AE events were detected, the source of these events was clearly identified near the left and right edges of the package. With further progression of time, the source of AE activity spread towards the center of the package and eventually to the entire

length of the board until an electrical open circuit was detected due to rupture of a copper trace. In the case of CABGA boards, the gap between the onset of AE activity and electrical failure was much more significant than the HSBGA boards.

**Figure 8 - Bend Test Result of a Typical CABGA board**

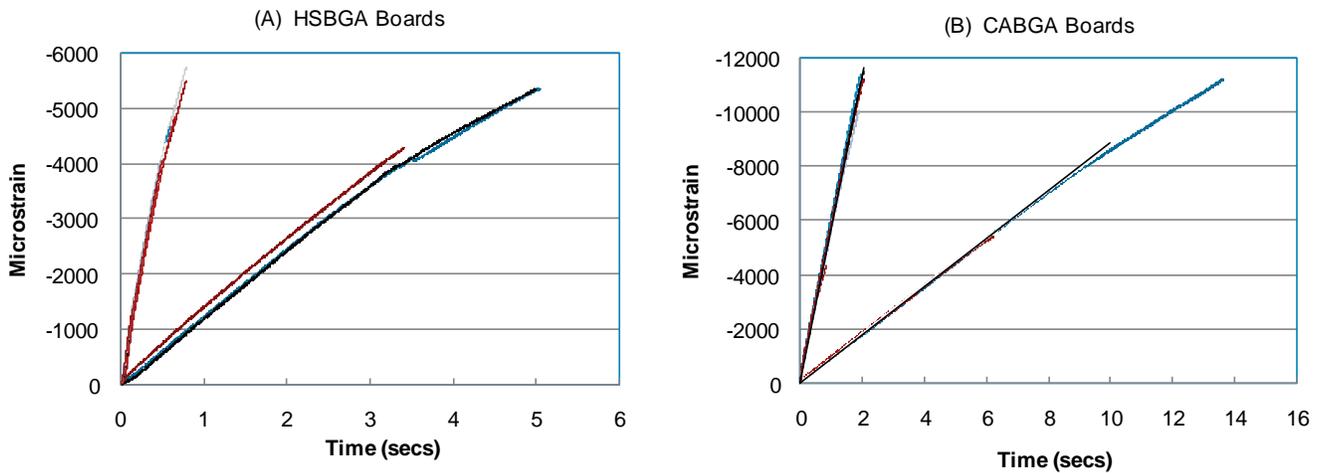
During the bend test, single axis strain gages were mounted on several boards. The strain gages, placed on the secondary side directly beneath the corner-most solder joint location, were used to determine the maximum strain on the board. Figure 9 shows the strain response from several HSBGA and CABGA boards tested at slow and fast cross-head speed. For the HSBGA boards, the strain rates were 1200 microstrain per second ( $\mu\epsilon/s$ ) and 8000  $\mu\epsilon/s$ . For the CABGA boards, the strain rates were 850  $\mu\epsilon/s$ , and 5700  $\mu\epsilon/s$ . Since there was good correlation in the strain results, the strain versus displacement relationship was established and used to determine the strain in boards that did not have strain gages attached.

**Figure 9 - Strain vs. Time Relation for HSBGA and CABGA Boards**

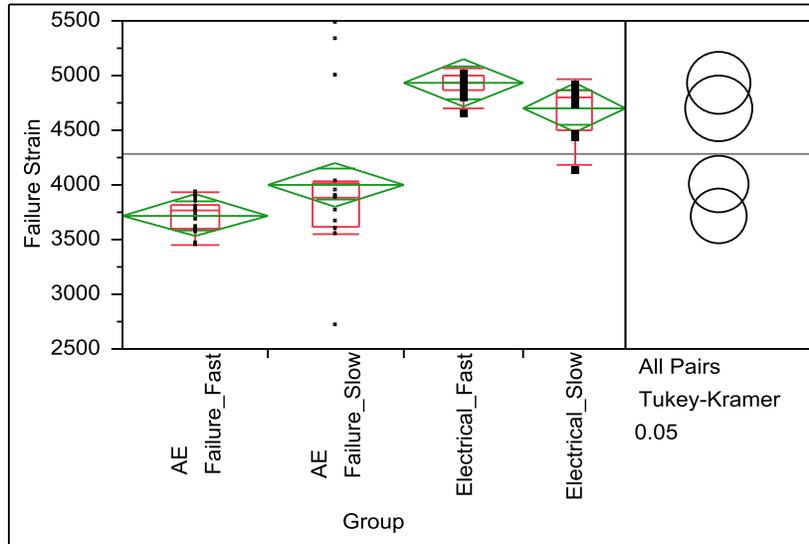
The PCB strains at the onset of failure determined by AE events and electrical failure are shown in Figure 10 for HSBGA boards. Note that in some cases the bend tests were terminated before any electrical failure occurred, hence the electrical failure strains for those boards were not shown in Figure 10. It is evident that the failure strains based on AE activity are significantly below the failure strains at the onset of electrical failure. Furthermore, the effect of strain rate on at the AE failure strain was not statistically significant, although the average failure strain was somewhat lower in the high speed tests and there was more scatter in the results with slow speed testing.

**Figure 10 - AE and Electrical Failures of HSBGA Boards**

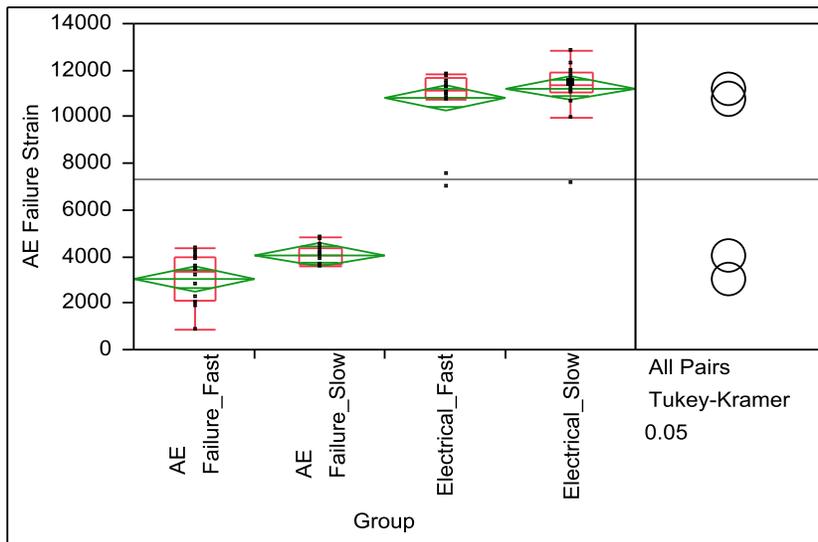
Figure 11 shows the failure strains at the onset of failure determined by AE activity and electrical failure of CABGA boards. In this case, the gap between the failure strains based on AE activity and electrical failure was even more significant. The electrical failure occurred at 3X higher strain than failures detected by AE. Also, the effect of strain rate was statistically significant for the AE failure. The high speed tests had AE failure at lower strains. The effect of strain rate was insignificant for the onset of electrical failure.

**Figure 11 - AE and Electrical Failures of CABGA Boards**

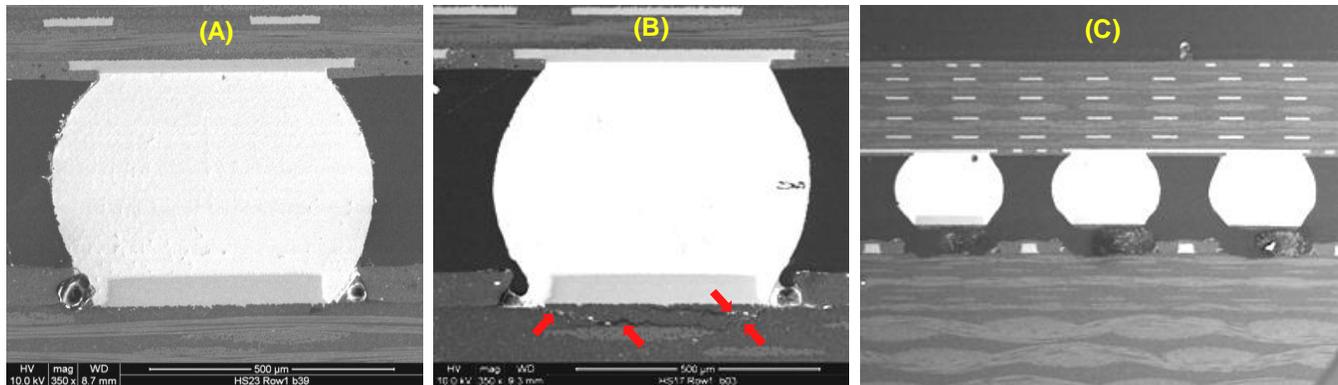
Dye and Pry and cross-sections were performed on selected test boards to ascertain the failure modes. The linear source location data from the AE system was used to determine which side of the package encountered the first failure, and the first row of solder joints along this side was cross-sectioned. All the failures in the HSBGA and CABGA test vehicles were found to be due to initiation of pad cratering cracks on the PCB side. Figure 12 shows SEM cross-sections from HSBGA boards where the bend testing was terminated at three different stages. Figure 12 (a) shows a typical joint from a board tested at slow speed up to a peak strain of 5000  $\mu\epsilon$ , and no high energy AE events or electrical failure was detected. Both sides of the HSBGA were cross-sectioned, and no pad cratering damage was observed. In this board, only 2 out of 80 solder joints observed had evidence of very minor shearing between the fiber bundles oriented at 0 and 90 degrees. This type of damage could easily be introduced in sample preparation or polishing. Figure 12 (b) shows a typical solder joint cross-section of another HSBGA board in which AE failure was recorded at 3900  $\mu\epsilon$ , and the test was terminated at 4000  $\mu\epsilon$  without any

electrical failure. Pad cratering was clearly evident in several solder joints along the edge of the package. As expected, the cracks originated at the PCB pad corner and propagated into the resin until the first layer of glass fiber bundles was encountered. Figure 12 (c) shows typical solder joints along the edge of a HSBGA board tested at high speed. In this case AE failure was recorded at 3900  $\mu\text{e}$ , electrical failure occurred at 4300  $\mu\text{e}$ , and the test was terminated at 4400  $\mu\text{e}$ . It is clear that in this board, where electrical failure was recorded, the failure had progressed to a significantly more advanced stage resulting in complete tearing away of the PCB pads and rupturing of copper traces connecting to the pads.

**Figure 12 - HSBGA board cross-sections (a) No AE Failure or Electrical Failure, (b) AE Failure but no Electrical Failure, and (c) AE and Electrical Failure**

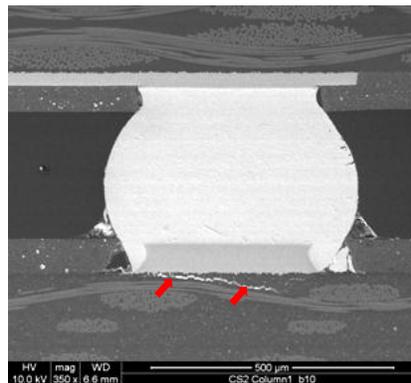
In the case of the CABGA boards, all of the tested boards had recorded AE failure, but several boards did not reach electrical failure. Figure 13 shows a typical solder joint cross-section along the edge of the package. This board was tested at slow speed, AE failure was recorded at 4000  $\mu\text{e}$ , there was no electrical failure and the test was terminated at 7000  $\mu\text{e}$ . Once again several solder joints had clear evidence of pad cratering on the PCB side.

**Figure 13 - Typical CABGA Cross-section with AE Failure but no Electrical Failure**

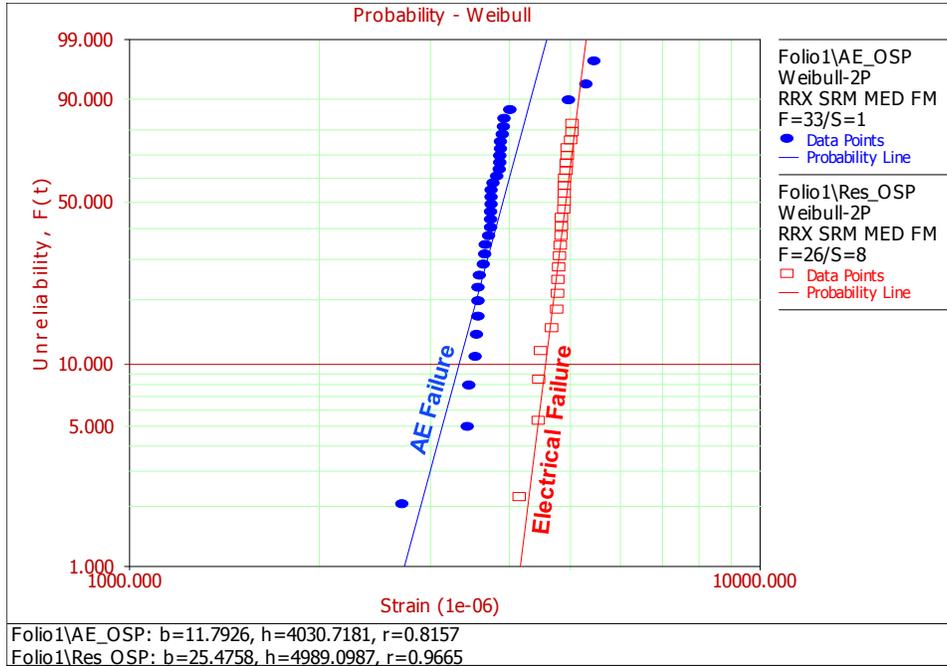
Figure 14 - Weibull Distribution Plot for HSBGA AE and Electrical Failure

The failure strains based on electrical resistance monitoring will significantly overestimate pad cratering resistance, and should therefore not be used to determine strain limits for actual PCB assembly, test, and handling operations. With use of the AE method, we can now see that the failures are initiating at significantly lower strain levels and by fitting an appropriate distribution it should be possible to establish the true strain limits. Figure 14 shows Weibull distributions for AE failure and electrical failure in the HSBGA boards. Since the effect of strain rate was statistically insignificant for the AE failures, the high speed and slow speed results have been combined. Using a 1% failure limit, it can be seen that the PCB strain limit to prevent pad cratering failures should be approximately 2500  $\mu\epsilon$ .

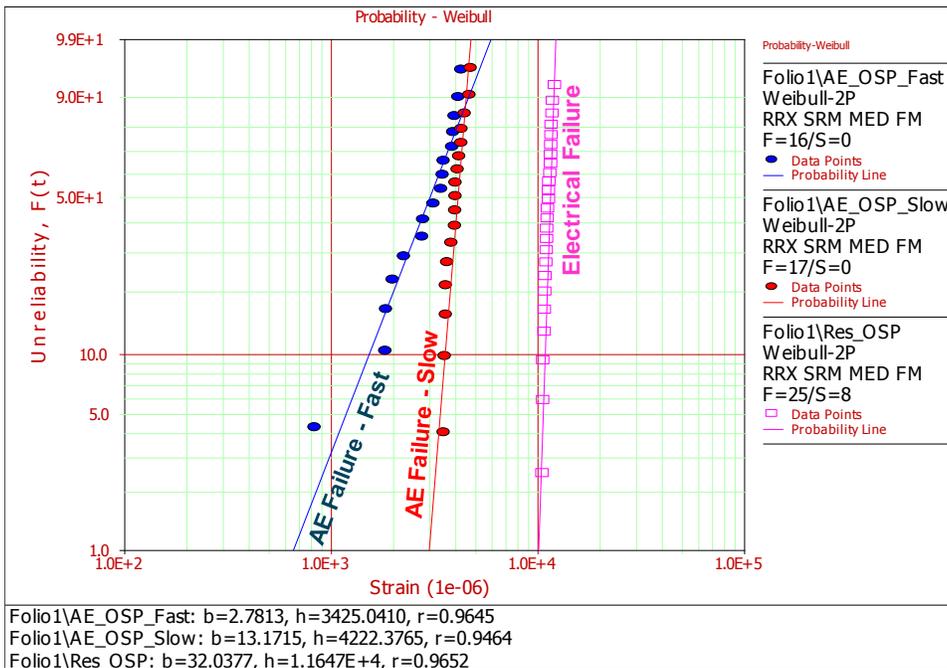
Figure 15 - Weibull Distribution Plot for CABGA AE (Slow, Fast) and Electrical Failure

For the CABGA boards, the Weibull distributions for AE failure and electrical failure are shown in Figure 15.

In this case the effect of strain rate was statistically significant (for AE failures) hence the distributions at slow and high speed testing have been separated. Based on a failure limit of 1%, the PCB strain limit under high strain rate will be approximately 650  $\mu\epsilon$ . The lower strain limit in high strain rate tests may be due to the increased stiffness of the Sn-Ag-Cu solder under high strain rate conditions, which will transfer higher stress to the PCB pad [16]. Since these types of packages have significantly delayed electrical failures, in the past small plastic BGAs were incorrectly assumed to be at low risk for pad cratering. The results in this study clearly show that the effect of the smaller pad size is very significant. Therefore in spite of a smaller package size and relatively lower package stiffness, the CABGA packages have a considerably lower PCB bending strain limit.
