Investigation of Pad Cratering in Large Flip-Chip BGA using Acoustic Emission

Anurag Bansal, Cherif Guirguis and Kuo-Chuan Liu
Cisco Systems, Inc.,
San Jose, CA
anurbans@cisco.com

In this study, the AE technique is used to systematically investigate pad cratering in a daisy chain 40 x 40 mm Flip-Chip BGA (FCBGA) package with lead-free SAC305 solder balls and 1 mm ball pitch. AE sensors have been attached to a four-point bend test vehicle to determine the onset of either pad cratering or brittle IMC failures. A two-dimensional AE source location method has been used to determine the planar location of failures on the test board. The test matrix is designed to investigate the effects of normal or diagonal strain orientation, NSMD or SMD PCB pads, and single or multiple reflow cycles. Physical failure analysis has been performed to correlate the test results with failure modes.

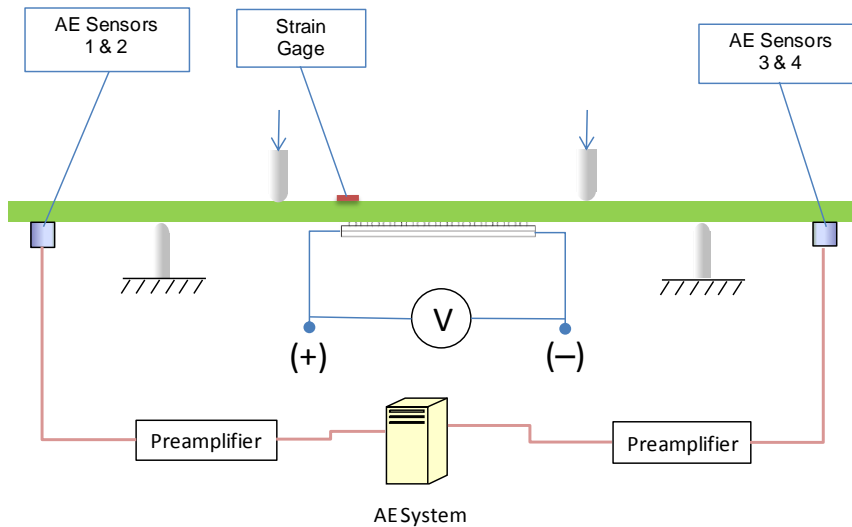
Figure 6 - Schematic of Bend Test Set-up with AE Sensors

Four point bend tests were performed according to IPC-9702 using daisy chain BGA test vehicles. Tests were carried out a strain rate of 5500 microstrain/second, in accordance with requirements of IPC-9702, because brittle intermetallic (IMC) fracture of solder joints is likely to occur only at high strain rate. Note that in our recent studies, it was demonstrated that pad cratering occurs at both slow and fast strain rates, but the strains required to generate pad cratering failure were lower at high strain rate [1, 2]. The bend test set-up is schematically shown in Figure 6. Details of the test matrix, including the variables considered in this study are shown in Table 1.

Four Acoustic Emission (AE) sensors were attached to the test boards to detect the AE events generated from pad cratering or BGA brittle fractures, and also to detect the location of the source of AE activity. In our previous work, two AE sensors were used to determine the linear location of AE events. In this study, with the use of four sensors the methodology was extended to determine the spatial location of AE events in the two-dimensional plane of the test board. These tests were done on assembled 0° and 45° boards, with a small load applied to ensure good contact between the anvils of the bend test fixture and the surface of the board. The algorithm for determining the location of an AE source relies on the velocity of sound in the PCB laminate and the time differential between detection of the same AE event at different sensors [1]. For this study, the orthotropic nature of the laminate was considered and different values were used for the velocity of sound (v_x and v_y), where X is the direction along the length of the board, and Y is along the width. Once the values of v_x and v_y were fine-tuned, a series of “pencil lead break” (PLB) tests were performed to calibrate the accuracy of AE source location. This is a simple procedure wherein the tip of a 0.5 mm mechanical pencil is broken on the board, at a approximately 60° angle from the surface of the board, in order to simulate an AE event. Since the position of the PLB test is known in advance, the location of the event detected by the AE system provides a means to evaluate, and iteratively improve, the accuracy of the source location. Figure 7 shows the AE source location result from a 0° board after pencil lead breaks at the package center, package corners, and near the loading anvils of the fixture.

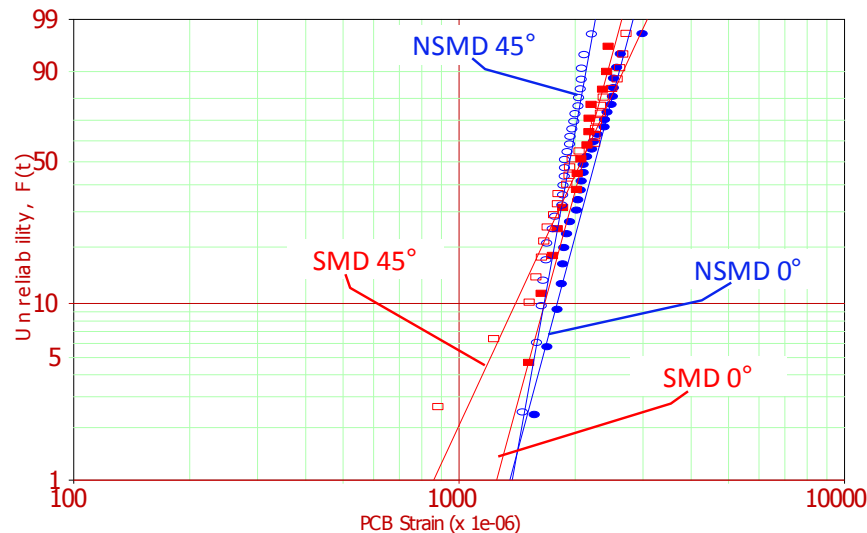
Figure 16 - Weibull Distribution of AE Failures

As noted in the introduction, the lack of a suitable board level test methodology to detect the onset of pad cratering has been a significant barrier for determining the PCB strain limits. The failure strains based on electrical resistance monitoring will significantly overestimate pad cratering resistance, and should therefore not be used to determine strain limits for actual PCB assembly, test, and handling operations. With use of the AE method, we can now see that the failures are initiating at significantly lower strain levels and by fitting an appropriate distribution it should be possible to establish the true strain limits. The AE failure data were fitted with a 2-parameter Weibull distribution for the cases of NSMD and corner SMD pads, with 0° and 45° orientations after 3X reflow preconditioning (Figure 16). Using a failure rate of 1%, the PCB strain limits were found to be in the range of 1250 to 1350 microstrain, i.e. very similar for all cases except the case of corner SMD pads with 45° orientation. In this case the strain limit was approximately 850 microstrain. The significantly different behavior of this case is not apparent in comparison of the mean failure strains due to a lower slope. Since the slope of the Weibull fit is often an indicator of the failure mode in reliability tests, it may be speculated that while mixed failure modes were observed with corner SMD pads, it appears that pad cratering was the dominant failure mode with the 0° orientation and IMC brittle fracture was the dominant failure mode with 45° orientation.
