TOP 5 BGA REWORK CHALLENGES TO OVERCOME (2016)

Bob Wettermann, MIT BEST Inc. Rolling Meadows, IL, USA bwet@solder.net

Key words: BGA rework, BGA warping, BGA underfill, mask repair, pad repair

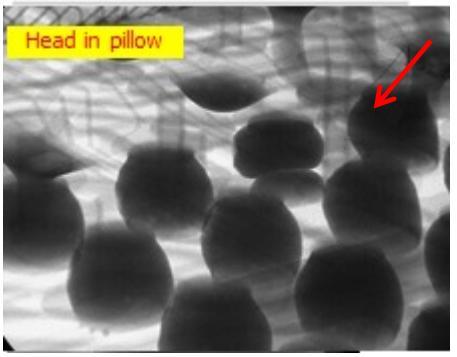
One of the challenges in reworking BGAs at this time is the warping of the packages as ever thinner packages lead to a variety of problems. A largely noted issue of a warped BGA is the 'Head in Pillow' (HiP) defect (Figure 1). This defect may or may not be detectable during the X-Ray inspection. In this solder joint defect the solder paste deposit will wet the pad, but does not fully wet the ball. This is due to the ball of the package being 'pulled away' during the device warping. The end result is a solder joint with enough of a connection to have electrical integrity, but not sufficient mechanical strength. Without the strength, these components may fail with a small amount of mechanical or thermal stress. This potentially costly defect is not usually detected in functional testing but rather in the field after the assembly has been exposed to some physical or thermal stresses. Warping can also cause bridging and shorts, at either the outer corners or the center of the device during replacement (Figure 2). This warping phenomenon can cause the center of the BGA to bow upwards and the corners down, or vice versa. Sometimes, this is enough to cause the corners to move closer to the circuit board surface. This puts extra pressure on the corner solder joints. Later in the lifecycle of the device, this wmayill cause shorts or cracks.

Figure 1: Head-in-Pillow Defect

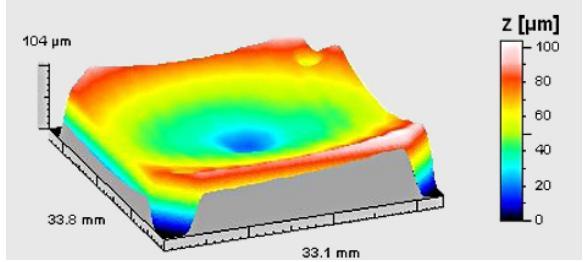
Figure 2: Warpage and z height deflection on BGA

There are several 'fine tunings' of the rework process which will mitigate the impact of warped packages. The main way to lessen the impact of warping includes the adjustment of the reflow profile and solder paste chemistry. The reflow profile will help determine which areas of the device may be subject to thermal stress as well as ensuring the flux activity level does not expire. The solder paste chemistry is an integral step in making sure there is plenty of flux activity if the warping occurs over a prolonged reflow cycle. These variables are important to control during the BGA rework process to minimize warping.

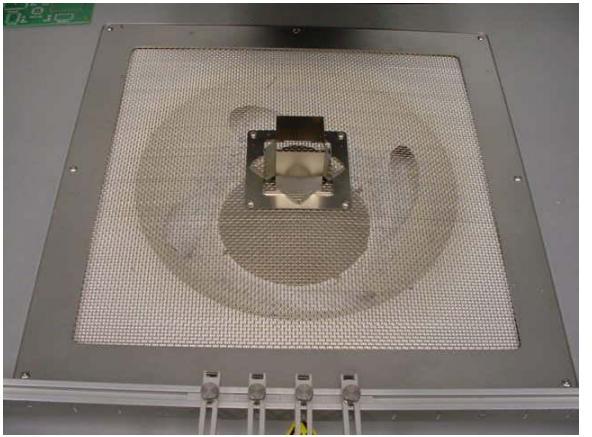
By aiming for a very small temperature differential across the entire BGA package -less than 10°C across the entire package is optimal, the impact of device warpage can be greatly reduced in the rework process. One of the methods for insuring a consistent and small temperature gradient across the entire package is to use a programmable multi zone bottomside heating source (Figure 3). Ideally, a multizoned heating source will heat the underside of the board to 100-120°C (lead-free processing temperatures) with the device location elevated to 140°C if the board and components can withstand this. This slight temperature differential will insure that there is not 'undo thermal stress', which may delaminate or warp the board. The heating nozzle (assuming hot gas is used as the reflow source) will bring the solder balls up to $20-30^{\circ}$ C above liquidus for 60-120 seconds.

Figure 3: Multizone bottom heat of BGA rework system

consistent collapse of the solder balls. Bottom side heat is especially necessary with thermally massive boards or for those processed using lead-free solder. This will prevent thermal damage to the PCB if the rework process is being done in higher liquidus temperature solders such as leadfree. Multizone bottomside heaters are sometimes necessary for higher layer count boards and to maintain a smaller temperature differential over the entire component area. Finally, the proper board support will help prevent warping of the board.

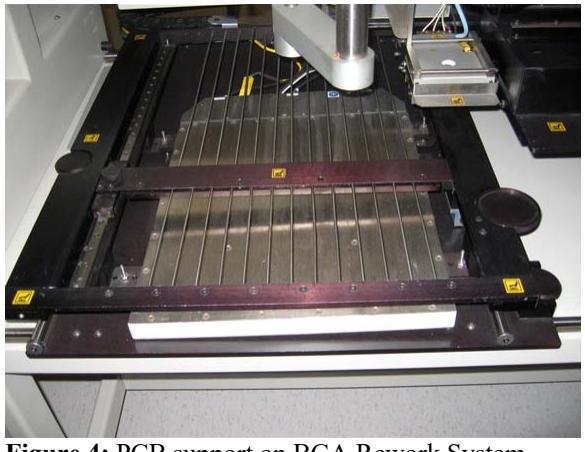
In addition to the proper removal and reflow profile, the PCB will need to properly supported in order to mitigate any effects of deflections on the PCB during the removal or reflow profiles. Board supports should be such that they prevent undue board deflections. An example of such a board holder can be found in (Figure 4). The lack of support further exacerbates warping which may occur.

Figure 4: PCB support on BGA Rework System

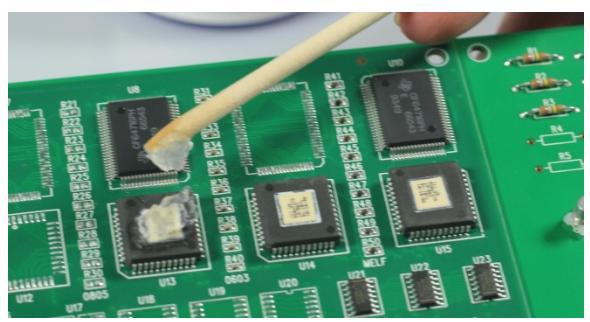
In order to prevent these negative impact on neighboring devices in the BGA rework area, proper thermal shielding is needed. A recent study (Wettermann, 2015) indicated that the shielding effectiveness of 'historical' materials, such as KaptonTM tape and stainless steel, are not as effective as more modern materials such as shielding clay gel (Figure 5) and ceramic nonwoven ceramic materials. In order to fully protect a device from thermal damage the study pointed out that the clay gel material is over two (2) times as effective as KaptonTM tape as a thermal shield at a close distance. and (3-4) times as effective at further distances. The ceramic non-woven fiber material is nearly as effective as the gel in terms of its heat withstand properties, but does not need to be cleaned off after use.

Figure 5: Clay Gel protects and shields devices from thermal damage

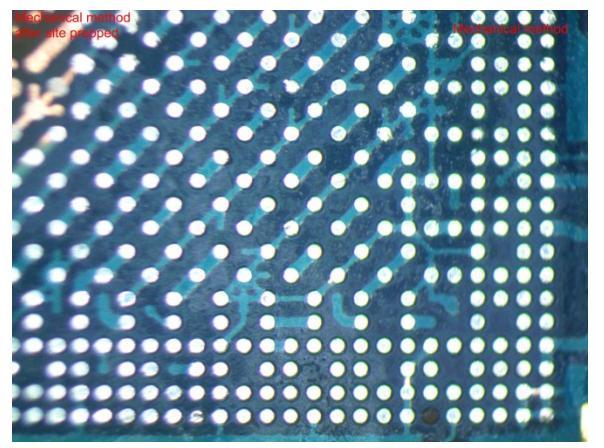
One of the ways to overcome the extensive damage caused by preparing the BGA site location after device removal is through the use of a high speed milling system. In this approach no direct heat is used to soften the underfill rather a high speed milling operation will "grind off" the cured underfill material as well as the remnant solder balls. This requires precision in this mechanical operation (Figure 6).

Figure 6: Mechanical Grinding off of underfilled BGA results

The softening point of the underfill is less than that of the reflow temperature of the PCB device. This means that under the BGA, as well as any non-protected device, the underfill softens and expands prior to the solder reaching liquidus state. This along with the resulting tackiness presents challenges in the removal of the device. During removal the underfill will 'squirt out' as local pressure pushes out the solder when it reaches reflow temperature. The result is a mess in the area of the underfilled device being reworked. Due to mechanical force, either through prying with a lever arm or a specialty nozzle in removing the underfilled device from the PCB, the board may end up with extensive damage. Due to the mechanical force, either through prying with a lever arm or a specialty rework nozzle in removing the underfilled device from the PCB, the board may end up with extensive damage (Figure 6).

By not grinding far enough, it will leave too much of the underfill at the BGA device location making the pads non solderable. Care must be taken during this rework method to ensure the mechanical vibration, and stress of rework, does not cause a decrease in the reliability of the PCB.

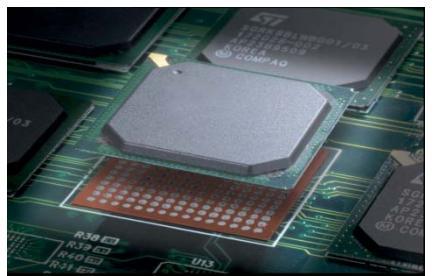
The last approach to repairing solder mask is through the use of a semi-permanent stay-in-place BGA stencil. This stencil, while having the benefit of being a simple way to place a BGA, also provides isolation between pads and prevents shorting between the IO. This will fix the standoff height between the base of the BGA and the PCB to control collapse height, while serving as a mask "band-aid". Once in place the stencil acts like a solder mask repair stencil. (Figure 7) This allows even the beginning repair technicians to repair damaged solder mask underneath the BGA.

Figure 7: Stay-in-place stencil for solder mask repair

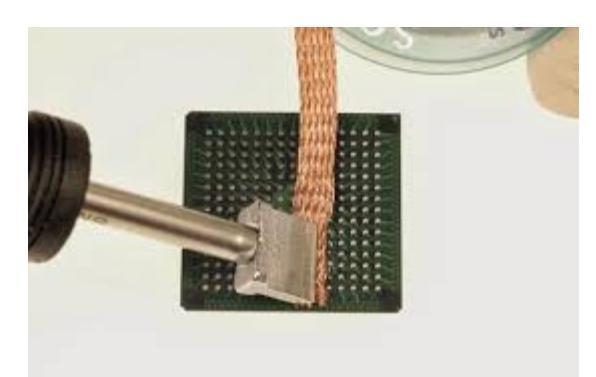
forth along the underside area of the BGA pad site. This can result in the mask being scratched and pads being bent up, or lifted off. The proper technique (Figure 8) calls for the solder braid to be moved in an 'up and down' fashion onto the pads thereby not scratching the surface or 'prying' the pads up.

Figure 8: Proper site preparation technique eliminates mask and pad damage

The proper procedure for the preparation of BGA pad sites, after a BGA has been removed is outlined in IPC 7711 procedure 4.1.3. and releveling of the pads is found in 4.2.1. The improper method for pad leveling involves 'scrubbing the deck'. This occurs when the wick is pushed back and
