## NASA DOD PHASE 2: SAC305 AND SN100 COPPER DISSOLUTION TESTING

Jeff Kennedy  
Celestica  
Minneapolis MN USA  
kennedj@celestica.com

Dave Hillman and Ross Wilcoxon  
Rockwell Collins  
Cedar Rapids IA USA  
ddhillma@rockwellcollins.com

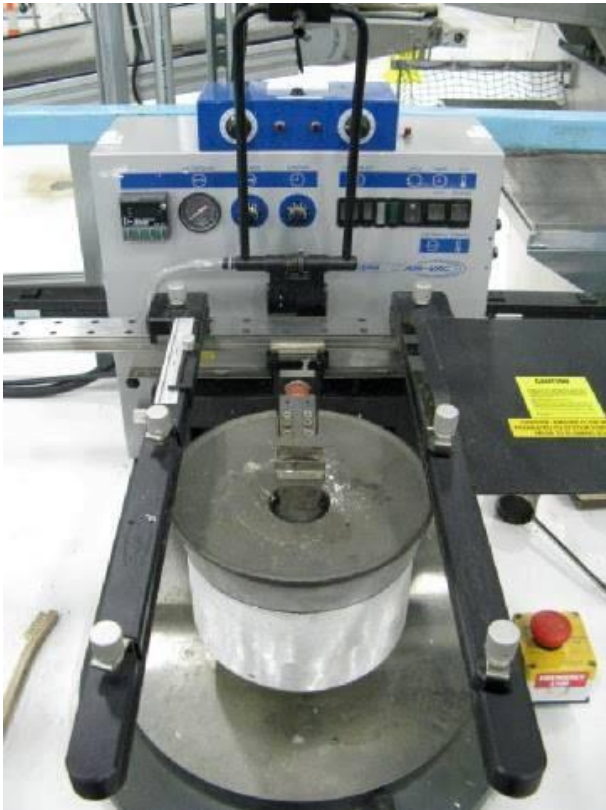
**Figure 2.** Wave Solder Equipment Setup

The wave height and contact area were validated using a quartz glass plate. Thermocouples were used to record temperature profiles for each of the timed exposures, which were conducted in an air environment. Figure 2 illustrate the wave solder setup.

An Air-Vac PCB RM12 Solder Fountain mini-pot wave machine was used for this test. A FWL-1248 nozzle was used for the SMT QFP footprint and a FWL-2448 nozzle was used for PTH DIP footprint. Both nozzles were a rectangular fountain type nozzle that completely covered the SMT QFP footprint and covered three PDIP component footprints. Two solder alloys were used: SAC305 (supplied by AIM<sup>[1]</sup>) and SN100C (Nihon Superior) with one at each of the two test facilities included in this study. Table 1 lists the solder alloy test information.

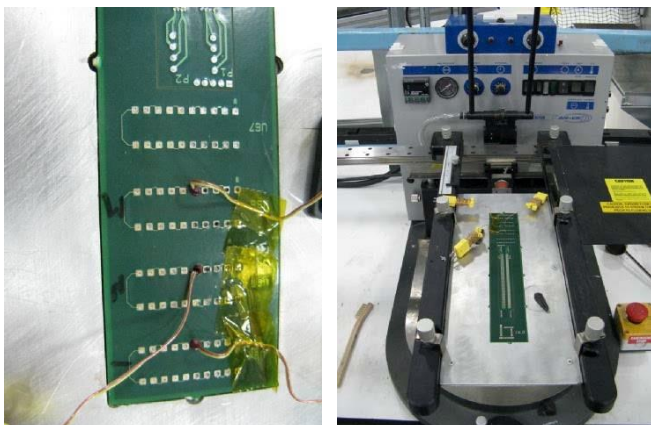
**Figure 3.** Left - Thermocouple Placement; Right - Wave Solder Equipment with Test Coupon

A fixture was fabricated to support the test vehicle for the exposures. This provided a stable platform for repeating the cycles and minimizing setup variability. Each exposure was thermal profiled using embedded thermocouples located at the PTH base, mid-point, and top locations. The machine/fixture and the thermocouple setup are shown in Figure 3. The solder flow rates were held constant across the various exposures.

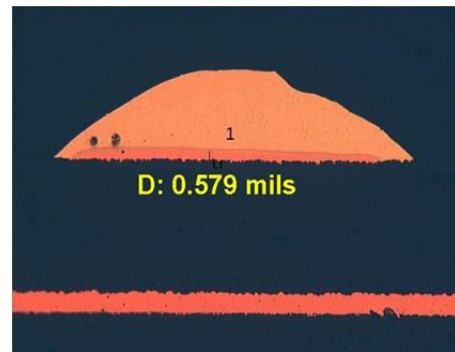
- Three sets of measurements (A, B, C) were taken on the test coupons.
- The “A” measurements were taken on the SMT QFP pattern.
- The “B” measurements were taken in the 10 hole PTH DIP pattern of those holes that were not exposed to the mini-pot wave solder (Masked with Kapton Tape) .
- The “C” measurements were taken at the 10 hole pattern of the PTH DIP for each of the 10 holes.

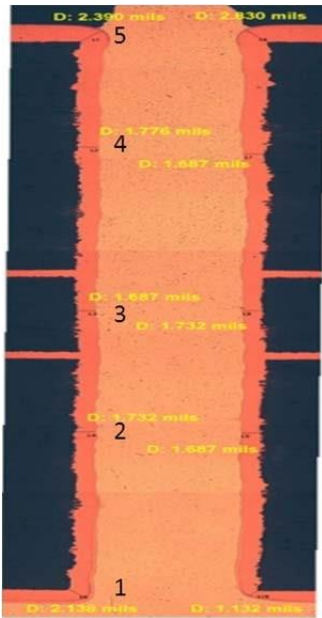
**Figure 4.** Rockwell Collins Dissolution Measurement Locations; Top - SMT QFP, Bottom - PTH DIP with Measurement Location Designators Shown

- PTH DIP copper thickness measurements were made at 10 locations for each plated through hole: the top plated through hole knee, ¼ of PTH thickness, ½ of PTH thickness, ¾ of PTH thickness, bottom plated through hole knee. Ten plated through holes were measured on each test coupon. These measurement locations are the same as those for the Celestica/SAC305 data with the addition of a measurement at the top plated through hole knee.
- SMT QFP copper thickness measurements were made at 6 locations for each test footprint: 3 pads exposed to the wave soldering process and 3 pads not exposed to the wave soldering process as a control. All measurements were taken at the center of the pad.

Figure 4 illustrates PTH DIP and SMT QFP cross-sections with the copper dissolution measurement locations and values.

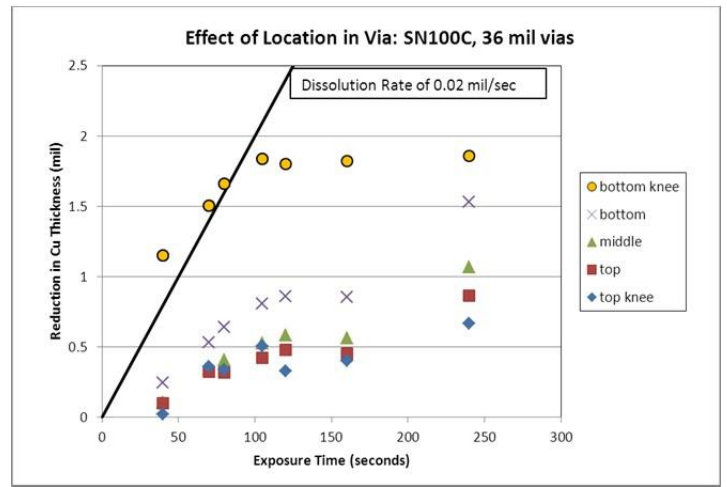
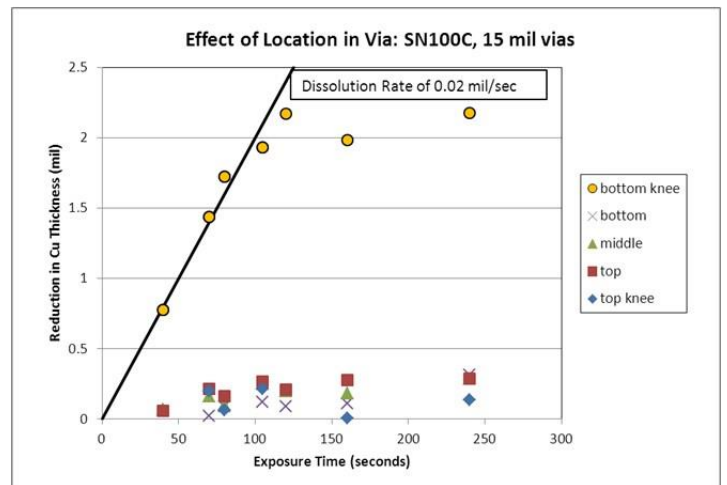
**Figure 5:** SN100C Copper Dissolution Results; Top - 0.036” PTH, Bottom - 0.015” PTH

The SN100C solder alloy copper dissolution test results are plotted in Figure 5. The PTH DIP test coupons with the 0.036” holes exhibit a linear dissolution of copper as the wave solder exposure time increases up to ~ 100 seconds. The PTH DIP test coupons with the 0.015” holes exhibit minimal-to-no copper dissolution even with longer wave solder exposure times. This is considered to be due to the reduced wetting and capillary action in the smaller hole, which inhibited the flow of molten solder into the barrel. This is not unexpected since the volume of alloy exposure to the copper interface is much greater for the larger hole. Other industry reports show similar results for larger PTH holes. This issue is exacerbated by Design for Manufacturing (DFM) rules for lead-free alloys, which require a larger hole to permit proper hole fill for PTH solder joints<sup>[1]</sup>. The plated through hole knees for both hole sizes exhibited completed copper dissolution for wave solder exposure times that exceeded ~70 seconds.

Figures 5 and 8 showed that copper is preferentially dissolved from the bottom of the hole towards the top. This is a result of the bottom side heating up first as it was exposed to the miniwave rework pot. Thus the copper at the bottom of the via had a

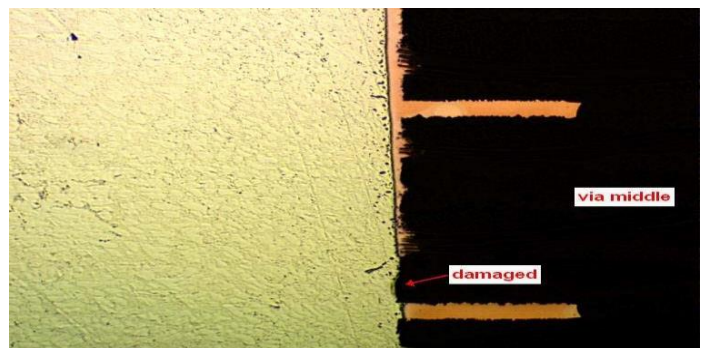
**Figure 6.** Damage example – PTH trace disconnected from PTH barrel

Figure 6 shows a trace that is disconnected from the PTH barrel and therefore represents a board defect resulting from excessive copper dissolution. DfX rules could redirect the location of these signal connections within the barrel towards the upper layers to minimize the risk of an interconnection failure in the product. Figure 7 illustrates a 0.036” PTH that was subjected to a total of 240 seconds of wave solder exposure. The PTH copper has been completely dissolved in the wave soldering process to nearly 30% of the plated through hole copper height.

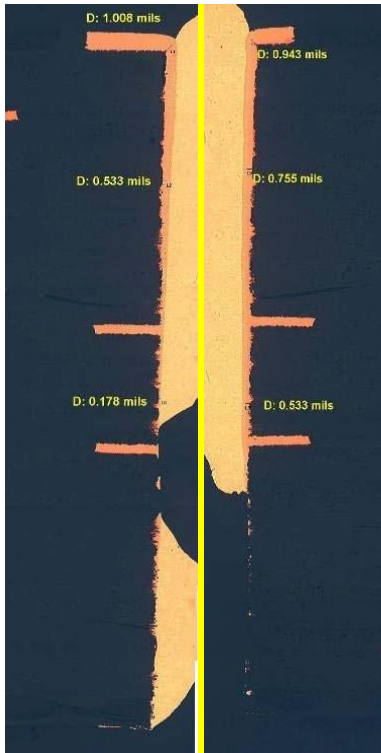
**Figure 7.** SN100C Cross-section of 0.036" PTH with 240 Seconds Exposure

Increasing the exposure time to the molten solder wave causes greater plated through via copper dissolution. The effective exposure time at the location depends both on the actual exposure time minus the time required for solder to travel from the surface to an interior location with the PTH. Therefore, as expected, the height of the plated through via also plays a role in the effectiveness of copper dissolution. Figure 8 illustrates how copper dissolution rates vary as a function of plated via measurement location along the length of the via. The bottom knee location had complete copper dissolution after approximately 100 seconds but the top knee location suffered only a reduction of 0.6 mils of copper after 240 seconds. This copper dissolution impact is important as product designers can make their designs inherently less vulnerable to the effects of copper dissolution by placing critical signal layers further from the printed wiring board lower half locations. Note that the dissolution rates shown in Figure 8 are specific to the particular via diameter and alloy used in this study. As will be shown in the subsequent sections of these reports, the smaller vias and other solder alloy showed significantly different rates of copper dissolution.

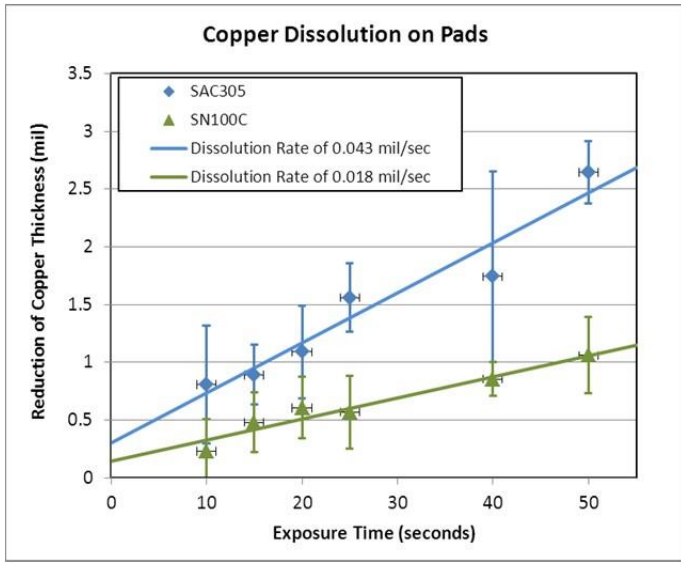
**Figure 9.** SAC305 and SN100C Copper Dissolution Results for SMT QFP

The dissolution rate of copper is a function of the specific solder alloy, via geometry, temperature and contact time during the PTH rework using a conventional mini-pot wave rework machine. Previous studies<sup>[2][10]</sup> have shown that preheat temperature also influences dissolution. These studies indicated that while a higher preheat temperature somewhat reduced the degree of copper dissolution by shortening the molten exposure time, the effect was not significant. In this study, the process temperatures were kept constant and the samples all started from room temperature. Figure 9 illustrates the differences in copper dissolution rates for the SAC305 and SN100C alloys for the SMT QFP pad feature. These results agree with industry literature, with the SAC305 solder alloy having a higher copper dissolution rate than the SN100C solder alloy.

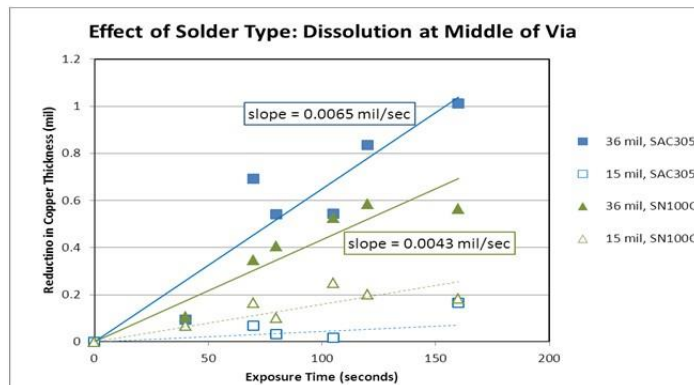
**Figure 10.** SAC305 and SN100C Copper Dissolution Results for PTH DIP at Middle Via Measurement Location

Figure 10 illustrates the differences in copper dissolution rates for the SAC305 and SN100C alloys for the PTH DIP via feature. This figure shows the rates of copper dissolution of the midpoint of the 36 mil and 15 mil vias for both types of solder alloys tested. As in the SMT QFP pad results, the SAC305 solder alloy has a higher copper dissolution rate than the SN100C solder alloy for the 36 mil via size. The influence of the plated through via feature is illustrated in Figure 10 as the copper dissolution rates for the SAC305 and SN100C alloys are very similar for the 15 mil via size. The geometry of the 15 mil via reduces the molten solder contact exposure, which reduces the effective copper dissolution rates. This influence of the plated through via size may be potentially be used in barrel design to address copper dissolution concerns depending on via requirements. It has been shown that larger hole to pin ratios are required for lead-free alloys [11] to enhance the via fill and resulting solder joint. However, as shown in this study, larger holes can exacerbate the copper dissolution interaction. Design considerations for lead-free products must take into account and balance the risks between copper dissolution and PTH solder hole fill.

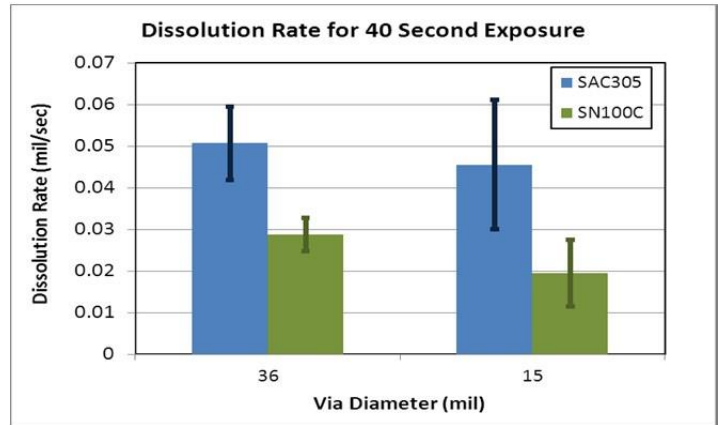
Figure 11 illustrates the slight differences in the average copper

**Figure 11.** SAC305 and SN100C Copper Dissolution Rate Comparison for 40 Second Exposure at Bottom Knee dissolution rates between the 36 mil and 15 mil via sizes for both solders that were evaluated. The error bars on this figure represent one standard deviation of the data.

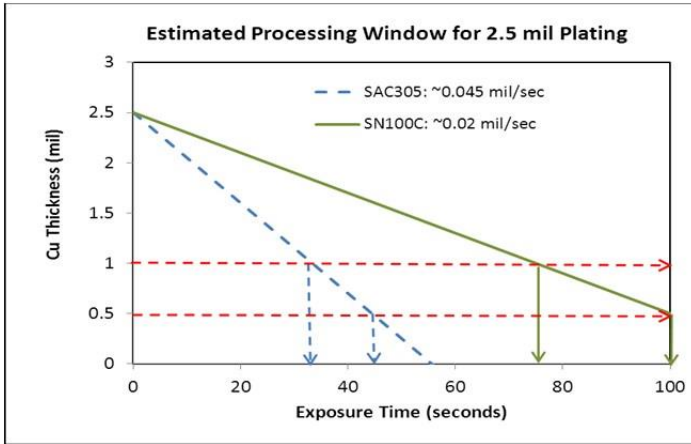
Figure 12. Mini Wave Soldering Processing Window Estimation

Since the dissolution of a plated through via knee is not readily detectible using typical assembly product stress screening, strict assembly process control limits are necessary to ensure acceptable product reliability. Figure 12 shows soldering process windows for the SAC305 and SN100C solder alloys for two classes of electronic products. The dissolution rates used to define the process window values correlate to the test results plotted in Figure 11. The minimum copper plating thickness required for Class 3 products is 1 mil and for Class 2 products is 0.5 mils.

Based on the investigation data, Figure 12 graph shows that the acceptable process window, i.e. maximum cumulative wave solder exposure time is:

- ~77 seconds for SN100C and ~35 seconds for SAC305 in Class 3 products
- ~100 seconds for SN100C and ~44 seconds for SAC305 in Class 2 products

The selection of a particular lead-free soldering alloy significantly impacts the allowable assembly process window. Some product designs that had adequate process windows using tin/lead solder would be impossible to process using some leadfree solder alloys, since the time required to remove and replace a component would result in copper plating thickness falling below the required Class 2 or 3 minimum values.

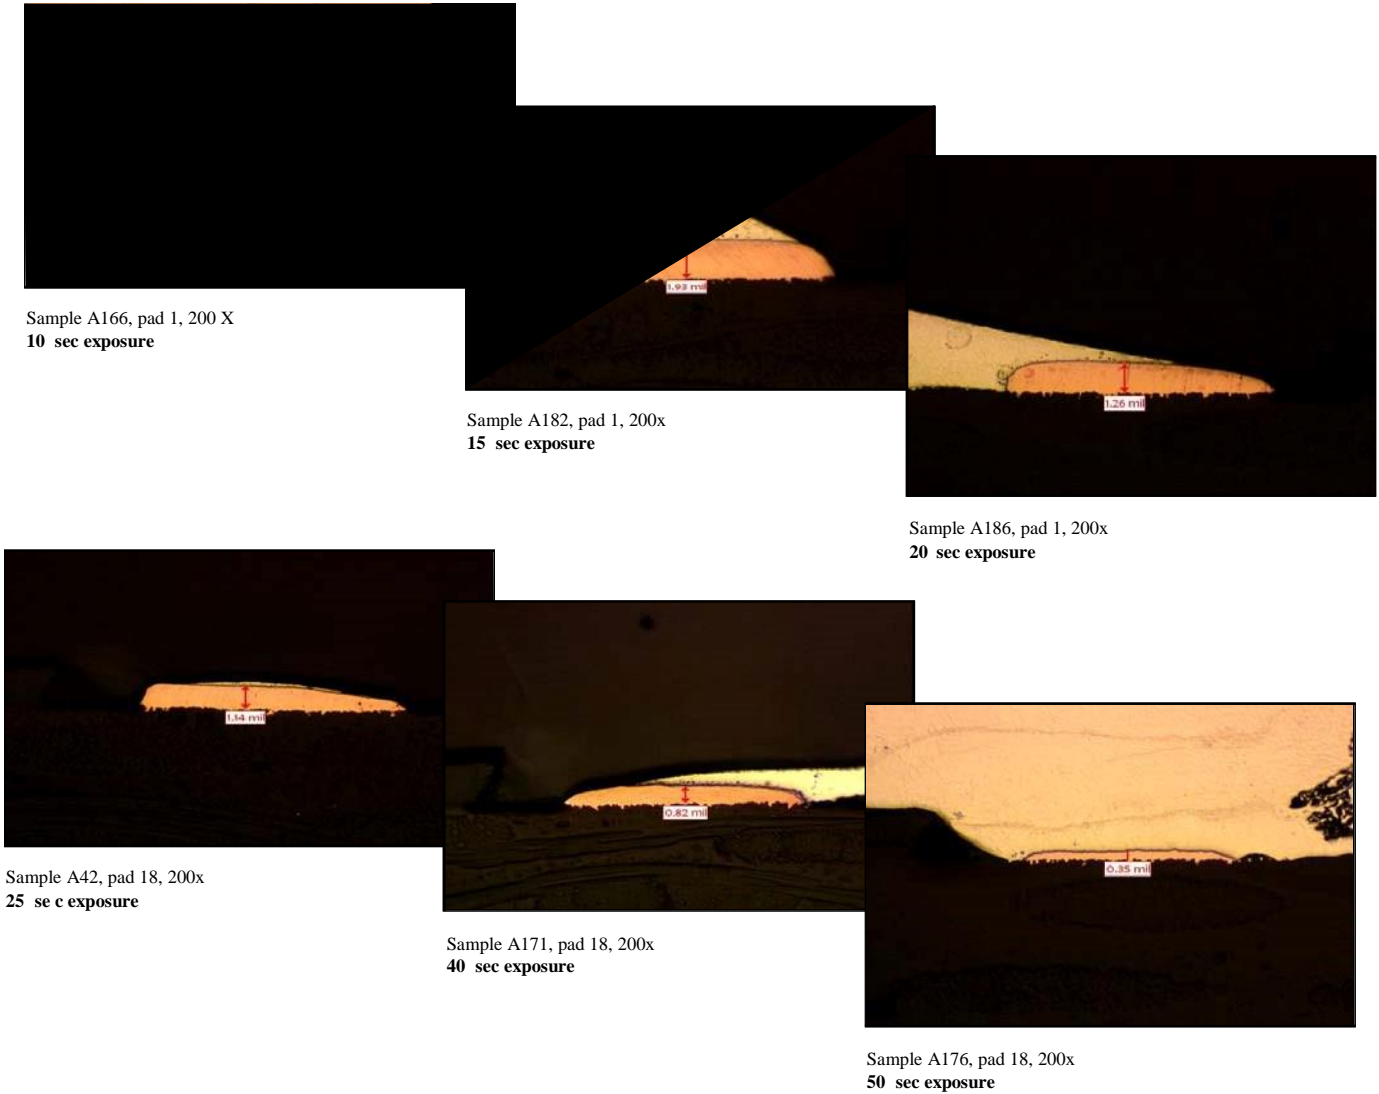
**Figure 15.** Sequence of Pad Copper Dissolution by Exposure Time

Figure 15 shows the sequence of pad foil copper dissolution over a period of time. The slope, i.e. the copper dissolution rate, was found to be approximately 0.04 mils/second. This is very similar to the rate of copper dissolution determined at the knee of the DIP PTH for SAC305.

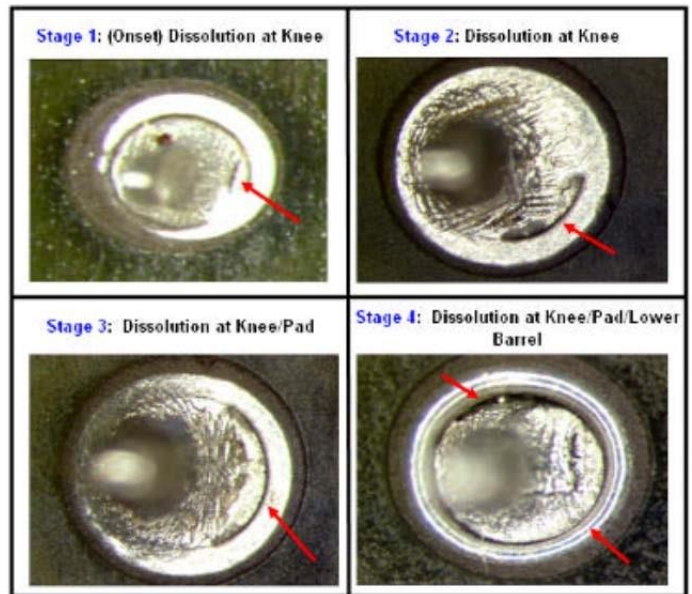
Visual inspection confirmed that the PTH catch pad and the knee of the PTH solder joint were the most susceptible locations for copper dissolution. The rate of copper dissolution is greater at this surface as compared to the inner barrel wall. Fillets at the knee may indicate a discontinuity at the location and may be a visual indicator for possible partial void/disconnection location. These visual indicators, illustrated in Figure 18 can be used by the operator to determine if there is an out-of-control process.

**Figure 18.** Visual Indicators of Copper Dissolution [2]: Knee-Pad- Barrel for Location of Copper Reduction Sequence

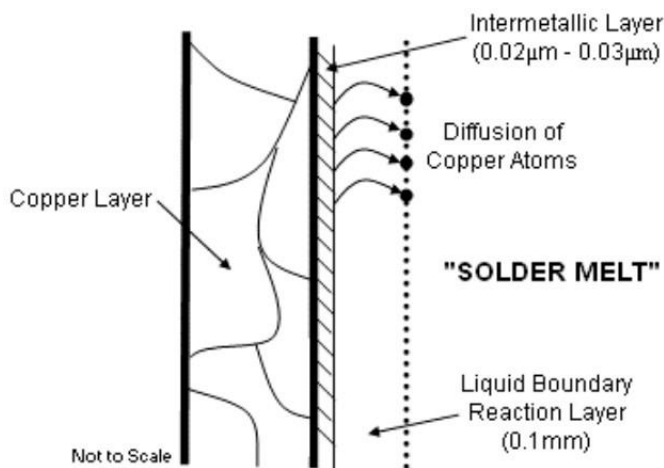
Diffusion controlled processes result in a uniform attack while interface controlled reactions may be recognized by preferential etching of grain boundaries. In this study, smooth copper/intermetallic interface without any sign of grain boundary attack was detected. The mechanisms occur in series and the slowest one determines the overall kinetics of the process. The most general dissolution rate equation is shown below [4]:

where C is the solute concentration at time t,  $C_s$  is the initial concentration, K is the solution rate constant and V is the volume of liquid. This equation can be applied for diffusion controlled or interface controlled processes. The solution rate constant K is D/d for the case of diffusion control, where D is the diffusion coefficient in liquid and d is the thickness of the effective concentration boundary layer. In general, the boundary layer thickness is less than 0.1mm. This boundary layer is a layer of liquid existing immediately adjacent to the solid copper interface/intermetallic layer (Figure 19). The copper concentration gradient exists within this layer. During the diffusion controlled process, the liquid boundary layer that is formed during the solder fountain rework is an important feature of copper dissolution.

**Figure 19.** Departure and Diffusion of Copper Atoms into Solder Melt (Kinetics of Copper Dissolution)

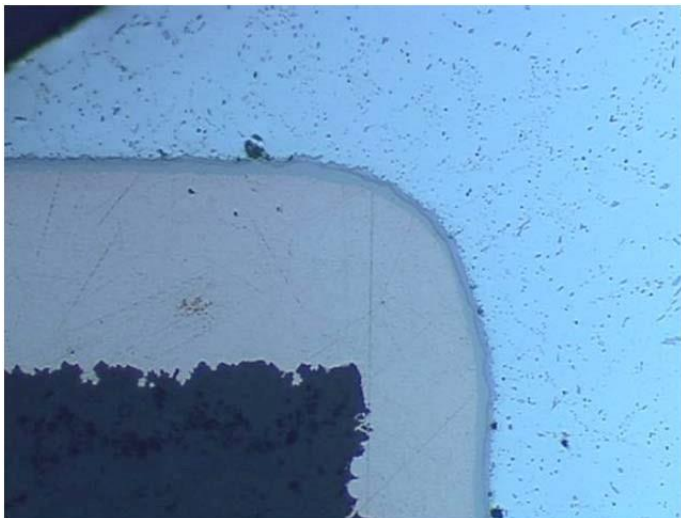
Figure 21. Impact of PWB Surface Finish on Copper

- The use of alternative printed wiring board surface finishes  
The characteristics of some printed wiring assemblies, such as the number of copper layers and/or how the plated through holes are connected, may make lead-free solder alloy rework/repair unachievable. Consideration of, and risk analysis for, the use of alternative printed wiring board surface finish such as electroless nickel/immersion gold (ENIG) that are plated on copper may be necessary. Figure 21 and Figure 22 illustrate the difference between two printed wiring board surface finishes. ENIG nickel plating in Figure 21 shows that the nickel plating protects 0.0015” of copper plating from copper dissolution even after 60 seconds exposure in a SAC305 flowing solder pot. The immersion tin surface finish shown in Figure 22 allowed nearly complete dissolution of the copper plating at the knee of the plated through hole for the same 60 second exposure time.

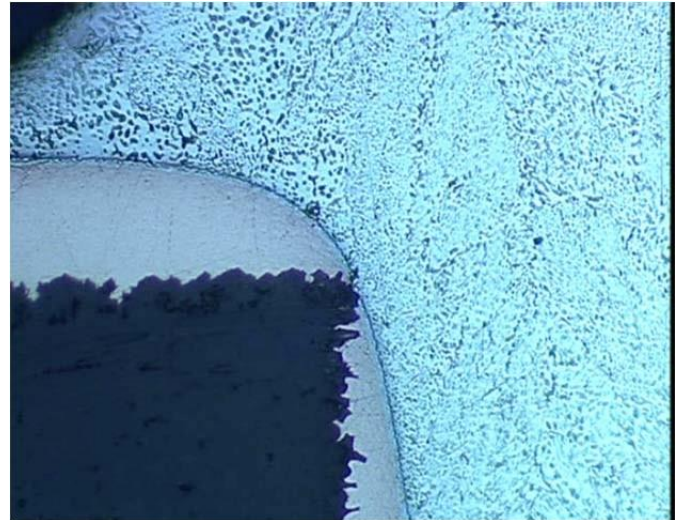
Figure 22: Impact of PWB Surface Finish on Copper Dissolution for Immersion Tin Surface Finish
