Conformal Coating over No Clean Flux

Karl Seelig & Timothy O'Neill

AIM

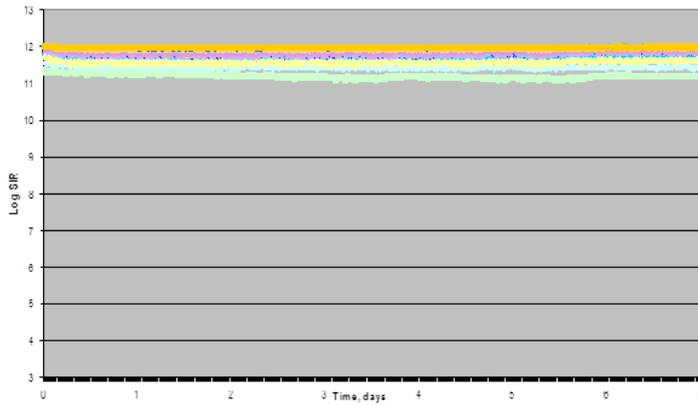
Chart 1. “L” UV Cure Coated, “Paste 54” (Sn-Pb), “Control”

All of the samples tested passed IPC SIR testing without issue. An example of the data generated found below:

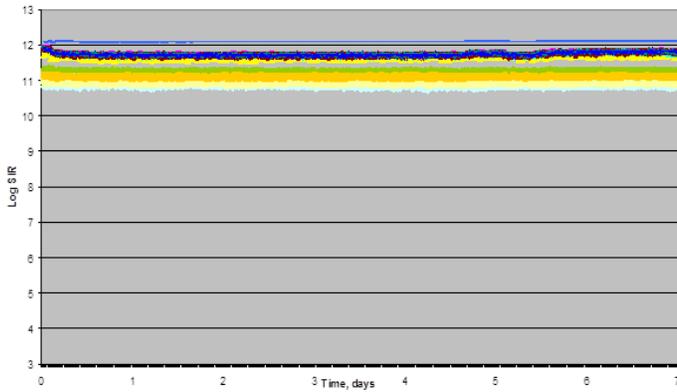
Chart 2. “H” UV Cure Coated, “Paste 54” (SAC305), Control

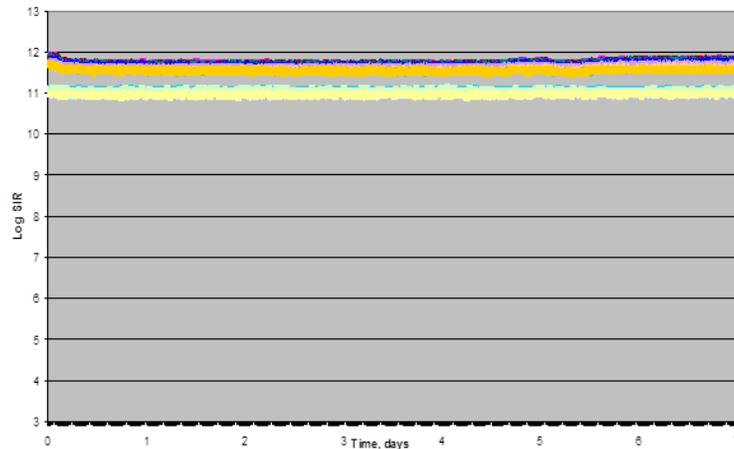
Chart 3. “H” UV Cure Coated, “Paste 54” (Sn-Pb), Control

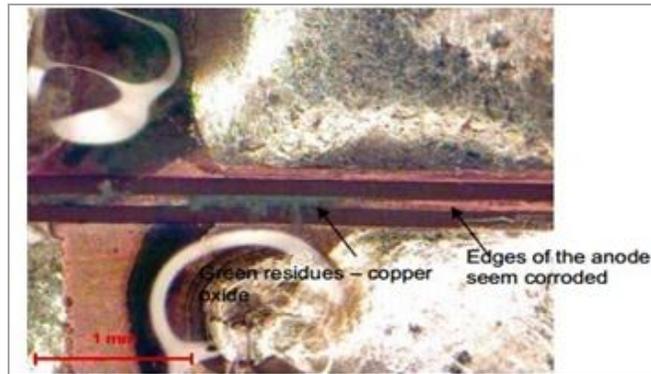
Figure 1. Moisture Absorption after Conformal Coat

With this information, it would seem the simple solution to this problem would be to incorporate a softer residue solder paste to remedy the delamination issue. Unfortunately, there is a significant impact to the SIR characteristics as detailed below in Figure 1.

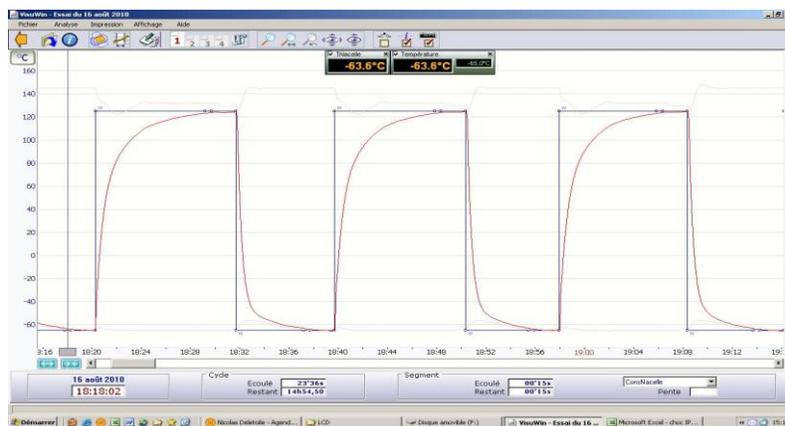
Figure 3. Profile

The results indicated that the silicon did not delaminate. Delamination is easy to see in the test as shown below. The following profile was used.

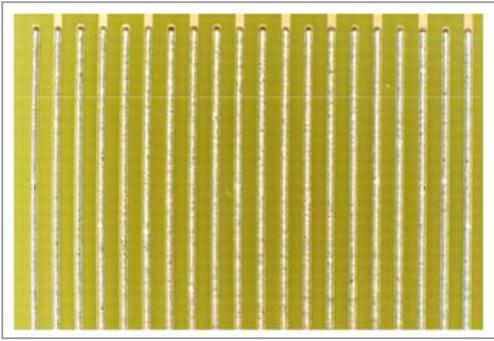
Figure 4. Pre Shock

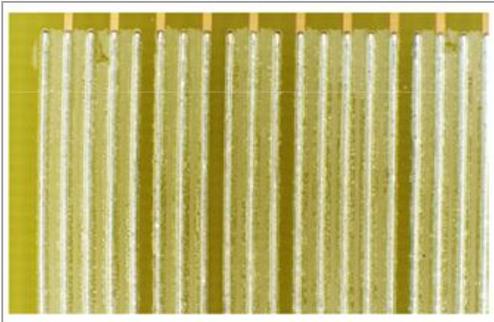
Figure 5. Paste 55 Post T Shock Delamination

Initial testing of thermal shock at -60°C $+125^{\circ}\text{C}$ showed gross delamination. Initially, it was thought the failure was due to movement of the flux residue having softened at 125°C . Further examination revealed that there was a cohesive failure of the flux residue, wherein the flux remained firmly adhered to the PCB substrate and to the coating, but failed internally (photo 3). This phenomenon was present on all coatings in varying degrees (other than silicone). In general, UV materials performed the worst, with solvent-based acrylics better and silicones the best, with no delamination. A failure was considered any evidence of delamination. It was not determined if delaminated coating that remained contiguous was still effective in protecting the underlying substrate.

Ultimately, we found the modulus of the coating is directly correlated to cold temperature failure. The CTE mismatch of the residue and a high modulus coating were enough to fracture the cold hardened flux residue. Flux medium used in solder paste is typically a resin-based material and after reflow, the residue is hard. The colder the environment is, the harder the residue. To test this theory, we varied the residue and the coatings using harder and softer materials. UV curable silicone having the lowest modulus of the materials tested and UV cure urethane the highest. We also tested a paste that is not resin based with residue that is waxy, rather than hard. As depicted below, reducing the modulus of either the coating or the residue eliminated the delamination failure.

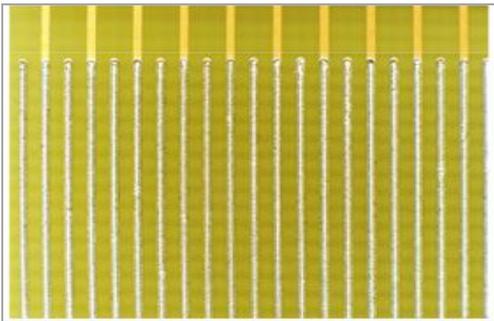
Figure 6. Paste 16 (low/no residue) Pre T Shock

However if the solder paste is a low/no residue nitrogen reflow solder paste delamination does not occur.

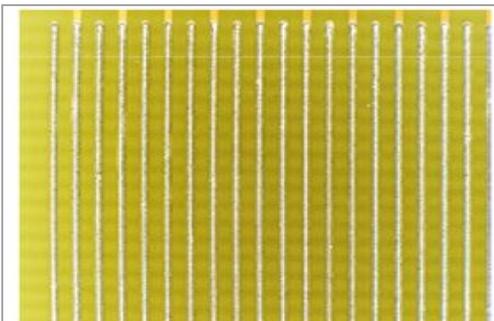
Figure 7. Paste 16 Post T Shock/No defects

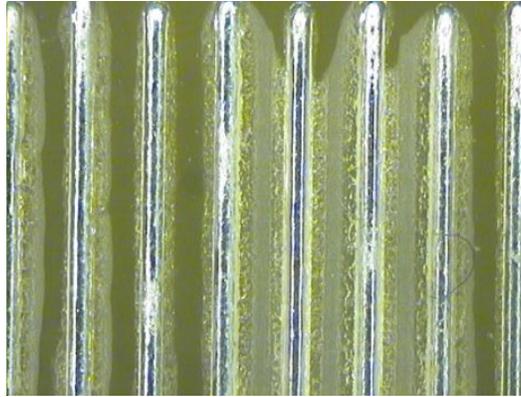
Photo 1
Delaminated after thermal shock testing

The following are a series of photographs that identify the hard flux issue with delamination of a harder urethane coating.

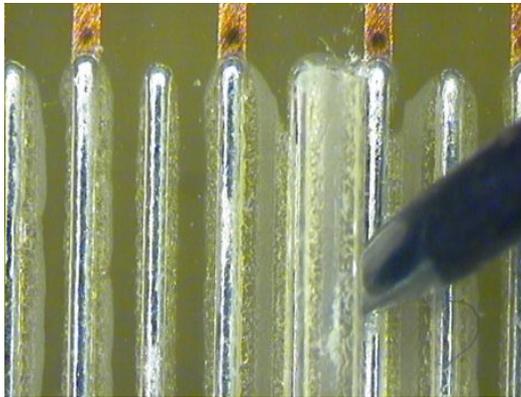
Photo 2
Delamination lifting off board

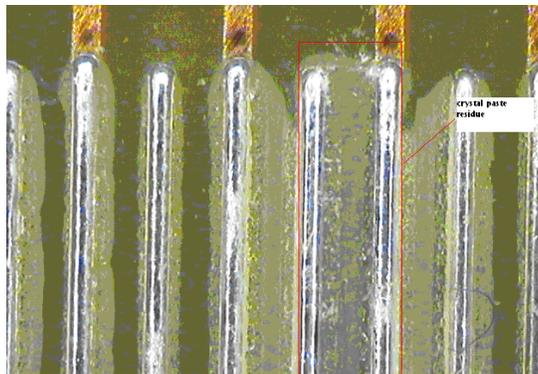
Photo 3
The crystal flux residue left on the board

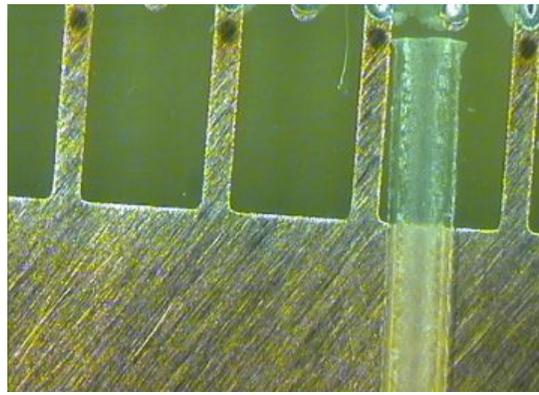
Photo 4
Crystal flux residue stuck to the coating

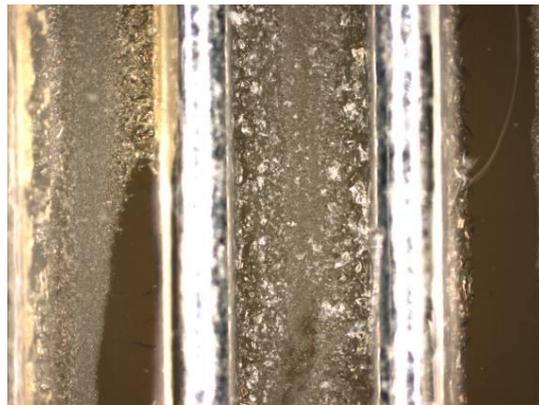
Photo 5
Close up of the above

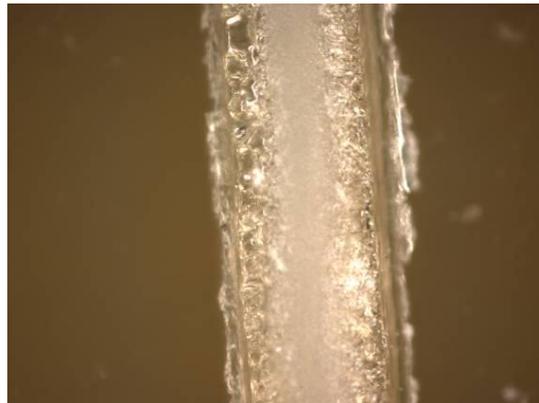
Photo 6
Close up of the above

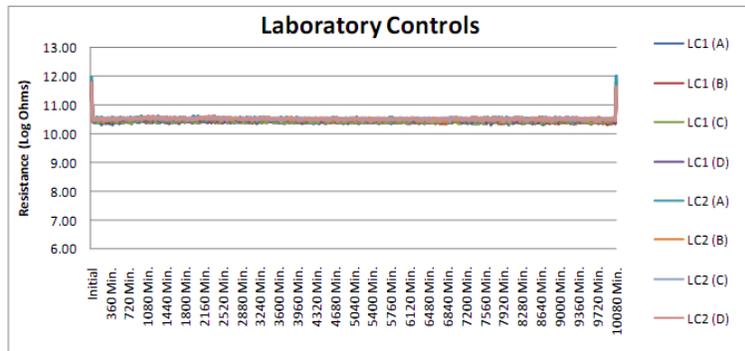
Figure 8. IPC 2.6.3.7 SIR Test (paste material coated with conformal coating).

Pictured below in figure 8 are SIR test results showing the beginnings of dendrites. These were run in 85°C/85Rh. SIR testing was also run at 40°C and 90 Rh. This test showed less failures compared to the 85°C/ 85Rh.

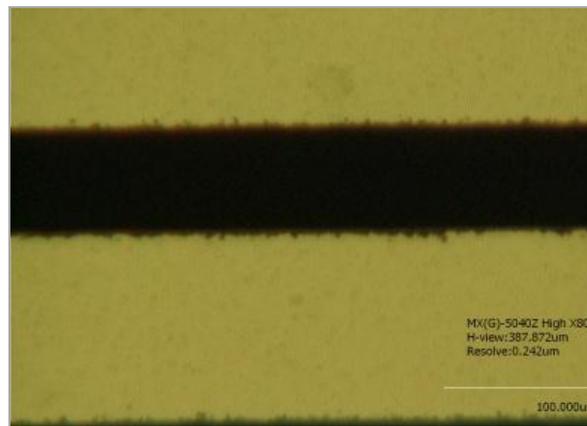
The below picture is of a comb pattern that was run at 85°C/85Rh. The dendrites are starting to grow.

Figure 9. Comb Pattern w/ Dendrites

Conformal coatings are not hermetic with all the materials tested having varying degrees of moisture vapor transmission. In this case, whereas moisture enters the coating, the softer residue solder paste absorbs the moisture and creates a “pressure cooker” of corrosion and electrical failures (shown in figure. 9).

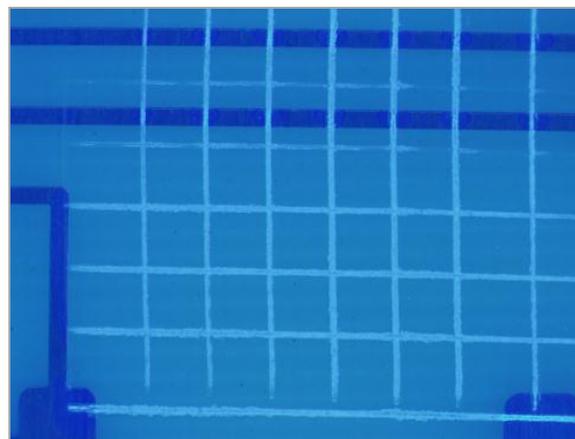
Figure 10. Black Light/Good Adhesion

Adhesion to board and flux residues can also be determined by using a crosshatch cut and applying tape to check adhesion as shown in figure (s) 10 & 11.

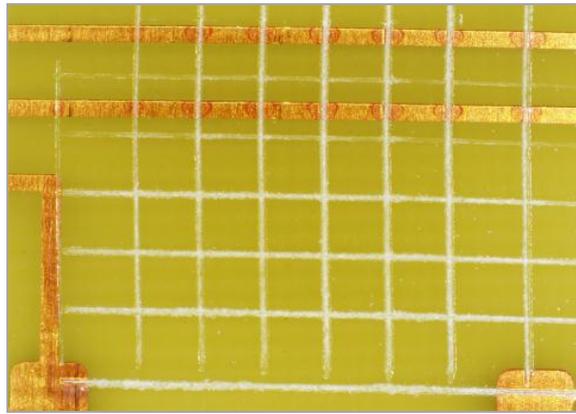
Figure 11. White Light/Good Adhesion
