# A SELECTED COMPARISON FROM ATC TEST: INDUSTRY PROGRESS FROM 2005 TO PRESENT DAY

John McMahon, Russell Brush, and Brian Standing  
Celestica Inc.  
Toronto, ON, Canada  
jmcmahon@celestica.com

This paper compares assembly and test of various 1.0 mm pitch CBGAs conducted between 2005 and 2014 and ranging from 32.5 x 32.5 mm and 937 IO to 55 x 55 mm and 2892 IO. Assembly yields and processes are compared as well as ATC test results. Weibull distributions and parameters are provided along with selected destructive failure analysis and discussion of the mechanisms.

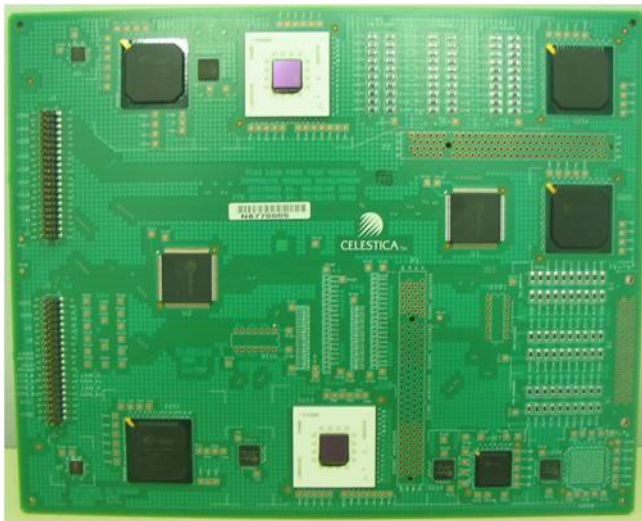
Figure 1: Comp A (Ria 3) test Vehicle

The white CBGA devices visible in Figure 1 have a 31 x 31 full array of solder spheres on a 1.0 mm pitch and had 6 locations depopulated in each corner for a total of 937 IO. The component side pad was 0.028 inches (710 μm), the board side solder pad was 0.024 inches (610 μm) and the stencil aperture was 0.022 inches (560 μm) in a 0.005" (125 μm) foil. The target range for the paste deposit was between 1500 and 2500 cubic mils and the process achieved an average of 1828 cubic mils.

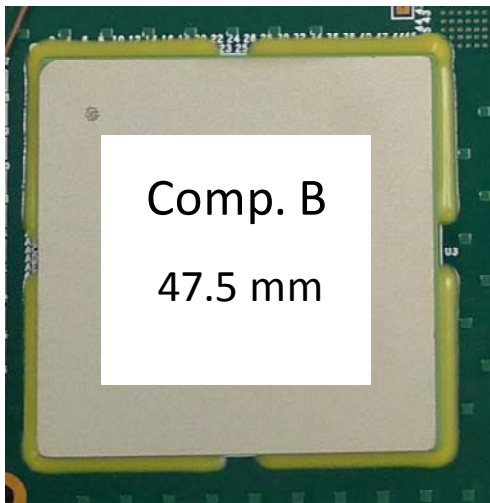
**Figure 3: Comp B with Edge Bond**

At a later date 24 Component B devices, 23 PA and 1 FR were independently assembled onto the same test vehicle and then reinforced with a high viscosity reworkable edge bond material in the pattern shown in Figure 3. The edge bond material was cured at 125 °C for 25 minutes.

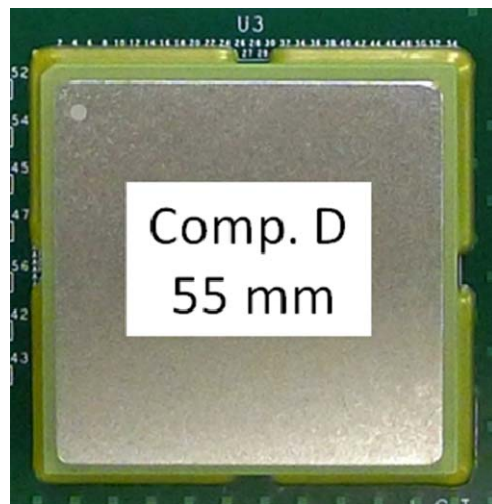
Figure 7: Comp D with Edge Bond

The high viscosity reworkable edge bond material with 50% filler was dispensed in an ‘L’ pattern around each BGA corner leaving a small gap in the centre of each side of the component. The edge bond material was cured at 125 °C for 25 minutes. An image of the dispense pattern is shown in Figure 7.

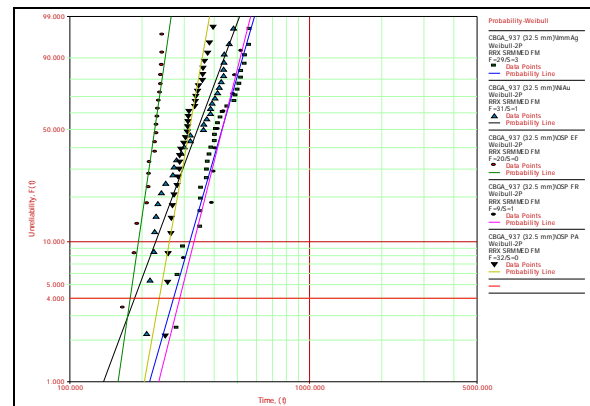
Figure 10: Comp A - Weibull Distributions

These failure modes have been separated in Figure 10 and are represented by two distinct distributions, early failure (EF) and primary attach (PA) for representative wear out mechanism. After separation the OSP lot had a calculated nominal 4% failure rate (B4%) at 235 cycles. Immersion Silver and NiAu had similar B4% values of 270 and 186 cycles respectively.

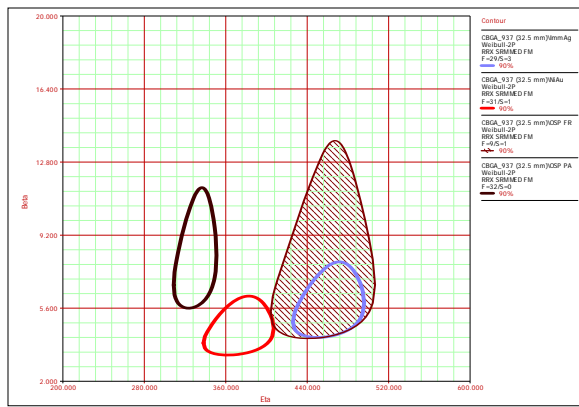
Figure 11: Comp A – 90% CC

However, we should note from the 90% confidence contours (CC) displayed in Figure 11 that the surface finishes are not in their standard order and that the FR lot performed significantly better than the PA lot. These two observations indicate that the OSP PA lot has some remaining issues which have not been identified. The real wear out mechanism may produce values nearly double those recorded in this test.

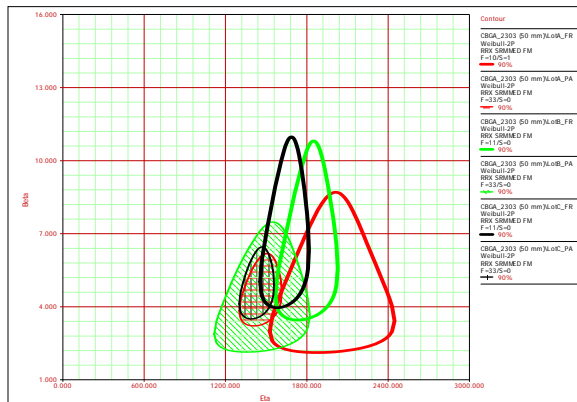
Figure 17: Comp C - 90% CC

Once again the stress concentration induced by the larger DNP and the implementation of SMD pads at the corners produces recrystallization and crack coalescence in the bulk solder near the top of the board level solder mask. Figure 18 and Figure 19 exhibit these effects at the A48 position of a FR component that was identified as a resistance failure at 1185 cycles and removed for destructive analysis at 1652 cycles. The B4% value for the entire 132 components in this project was 850 cycles.

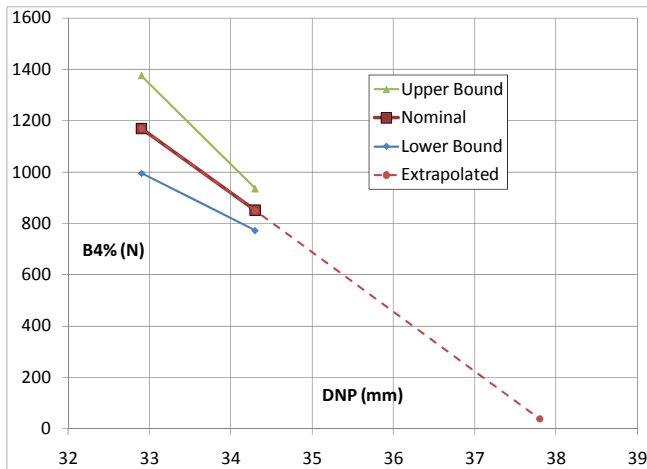
**Figure 25: Linear Regression B4% & DNP**

Comparison of the results associated with the B & C components leads directly to the requirement for some enhancement to standard solder attachment. The reduction in B4% value from 1170 to 850 appears to be related directly to DNP.

The internal component structures were unknown and the only real difference on the board side was the removal of SMD pads at the corners of the C component. One would expect the pad change to improve cycling performance rather than reduce it. This B4% reduction of 30% based on

the increase of DNP from 32.9 mm to 34.5 mm and the increasing mass of the component would lead one to predict a B4% below 50 cycles for a 55 mm component with a DNP of 37.8 mm assuming a linear relationship as depicted in Figure 25.
